Case Study 3

- Minneapolis, MN
- 1924 with remodels

Pain

Water intrusion

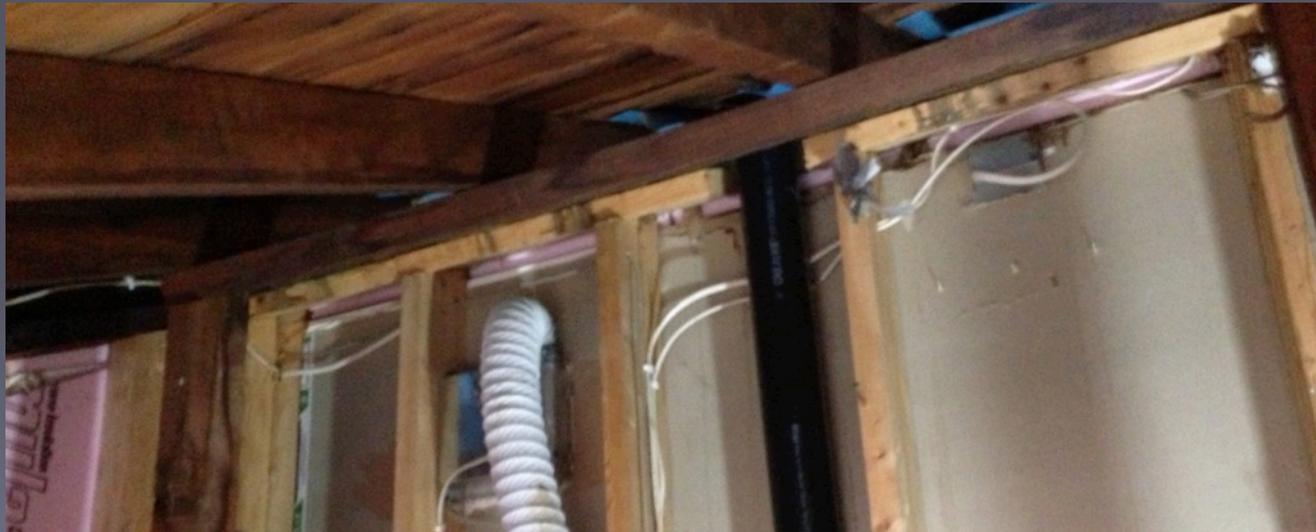
Remember this knee wall?

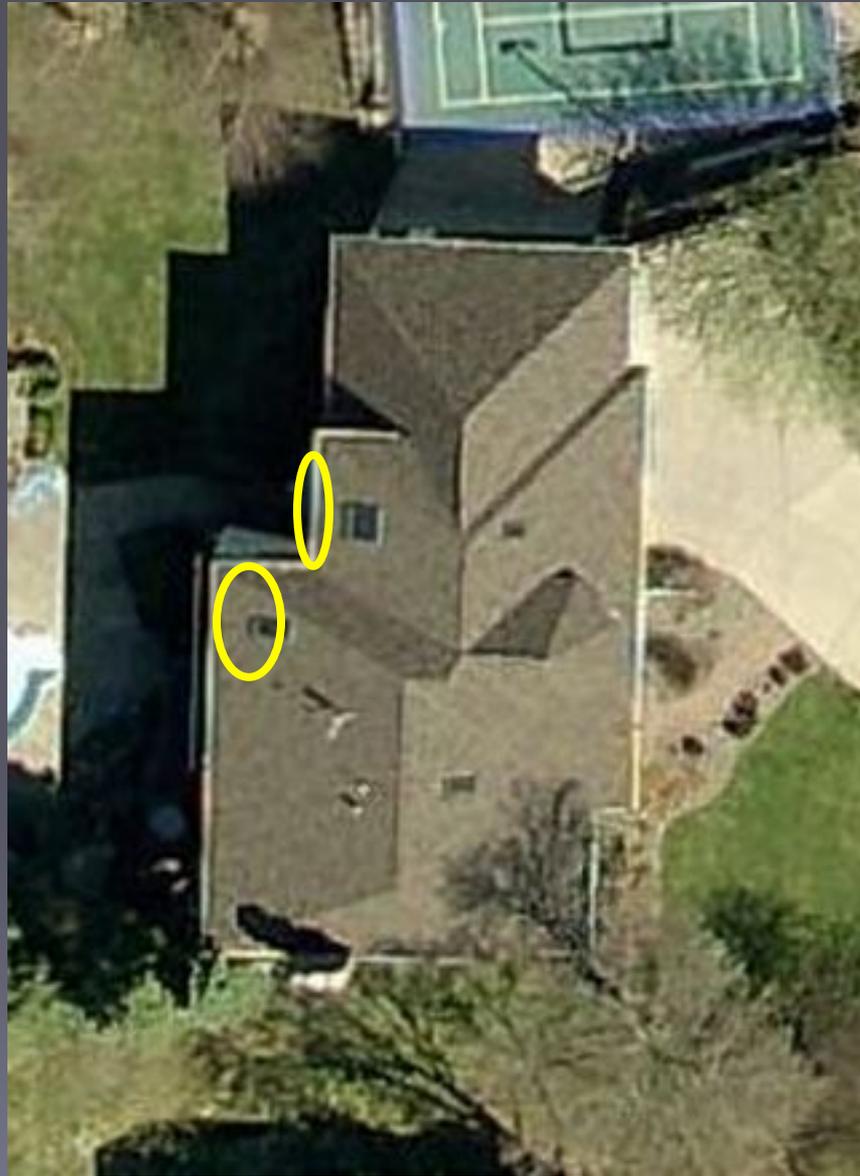
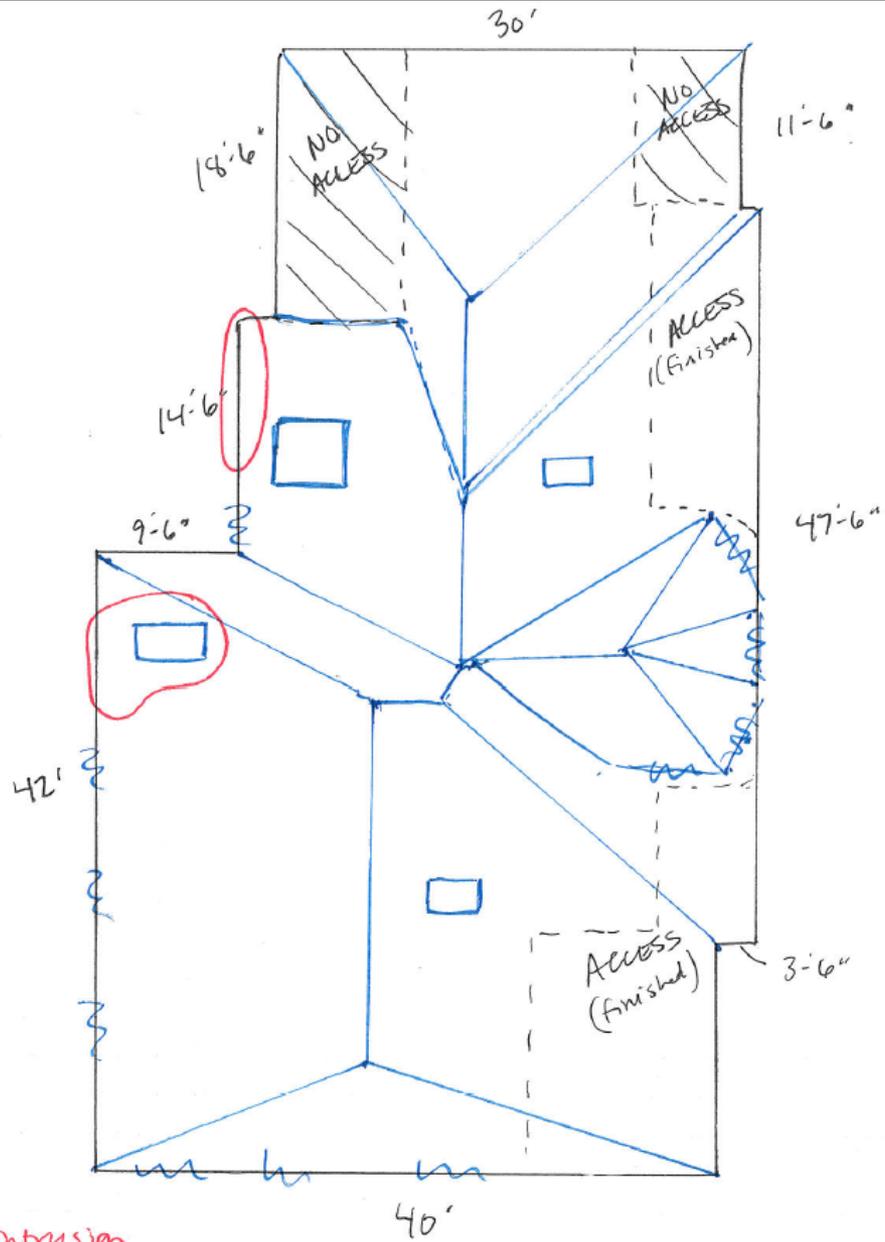
Visible water intrusion

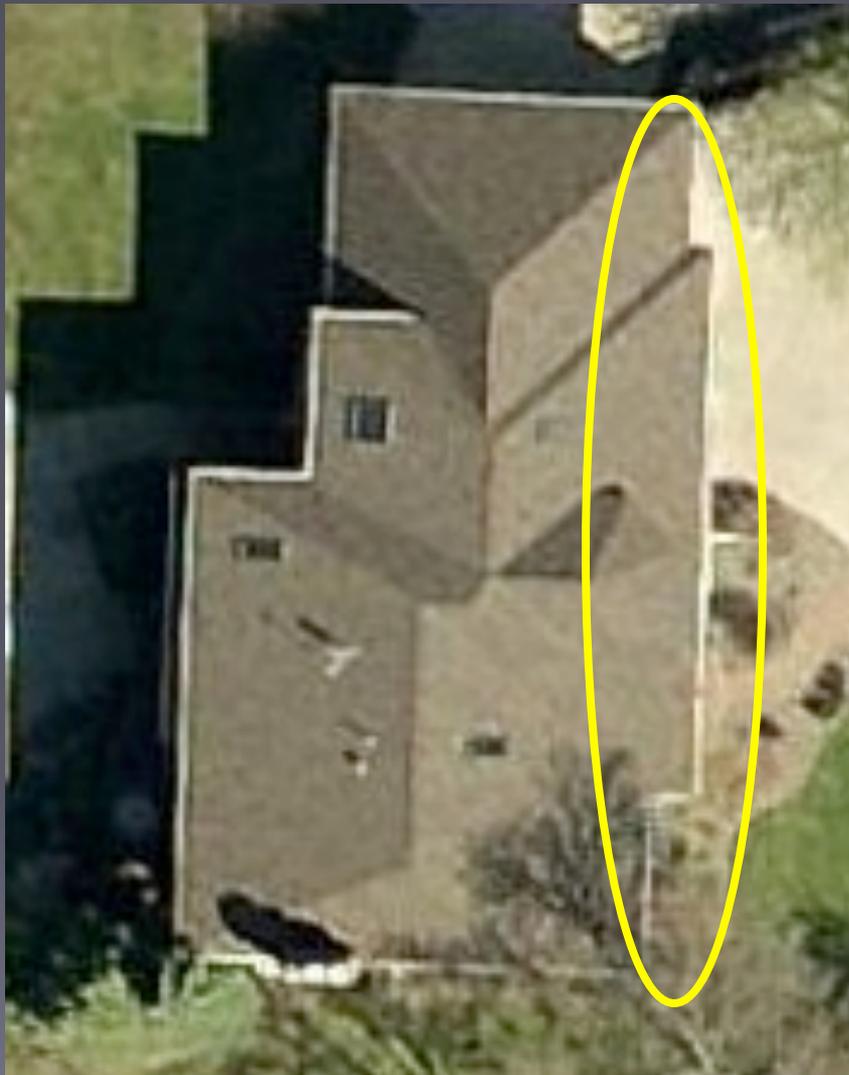
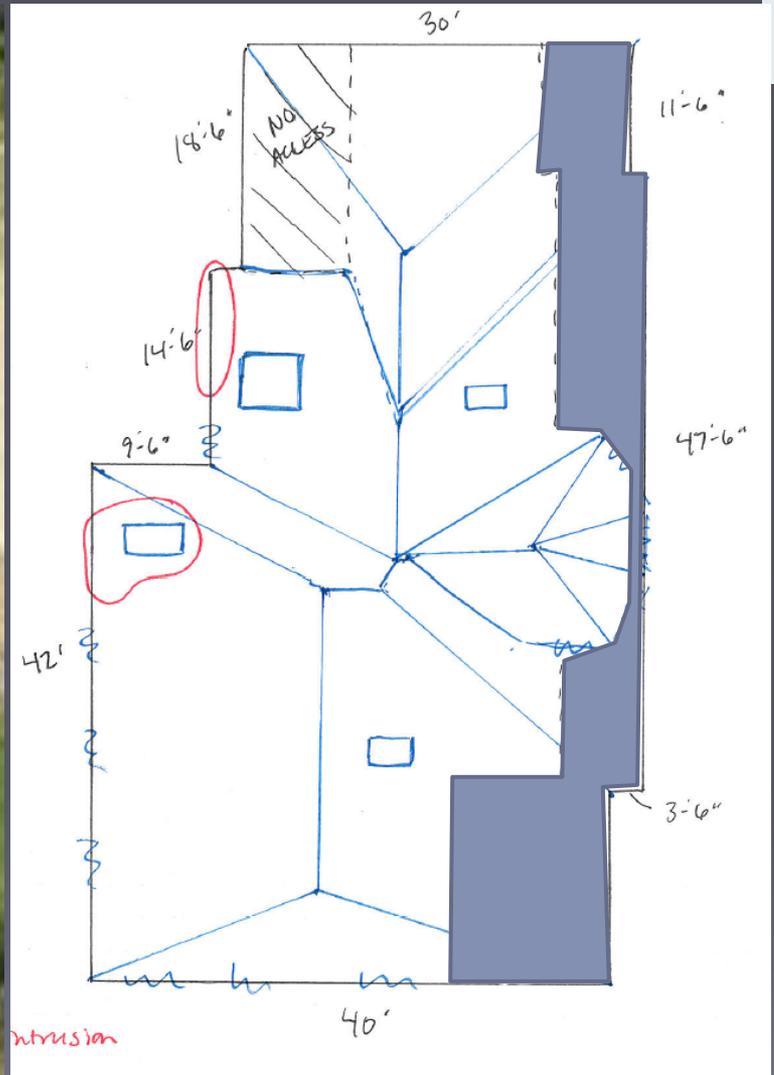
Effect of not air sealing front slant

What effects did not air sealing the front slants have?
