Blower Door & Infrared Imagery

Case Study 1

Case Study 2

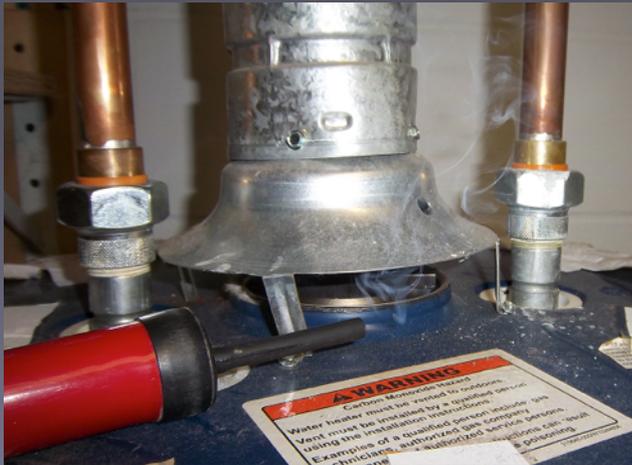
- Combustion Safety
 - Worst-Case Depressurization
 - Flue Gas Analysis

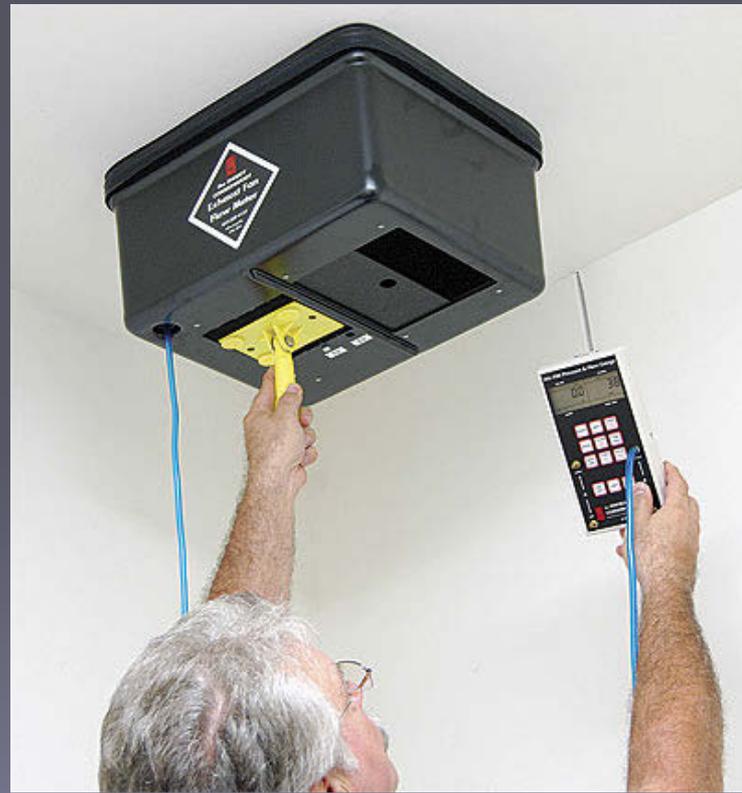
- Ventilation Assessment
 - Point Source
 - Whole House

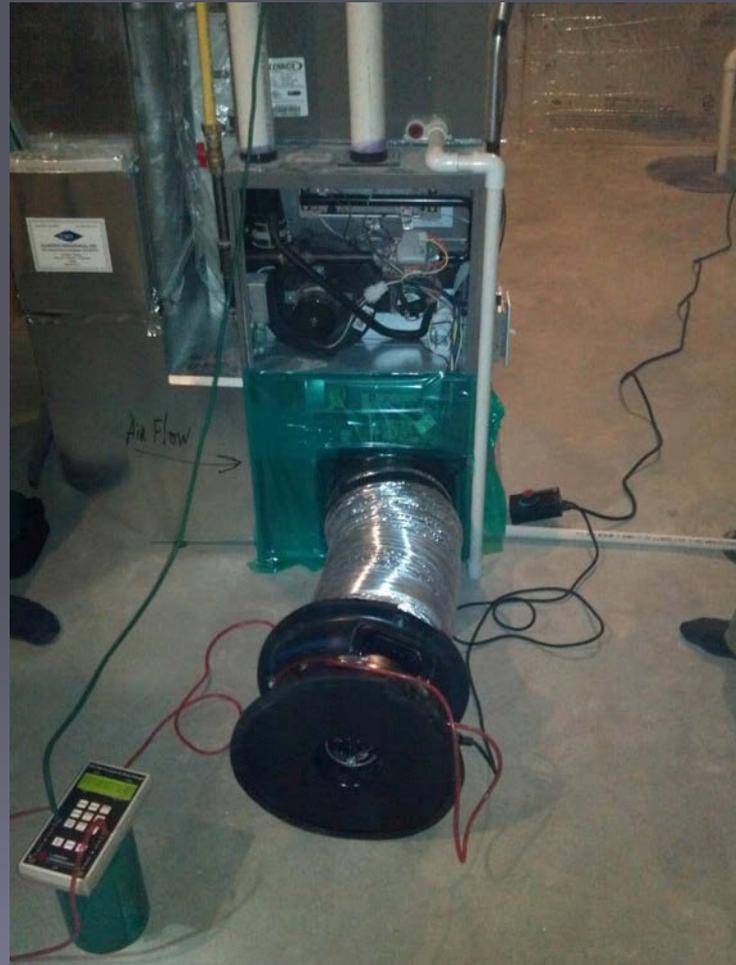
- HVAC Testing
 - Duct Blaster
 - Pressure Pan
 - Flow Blaster

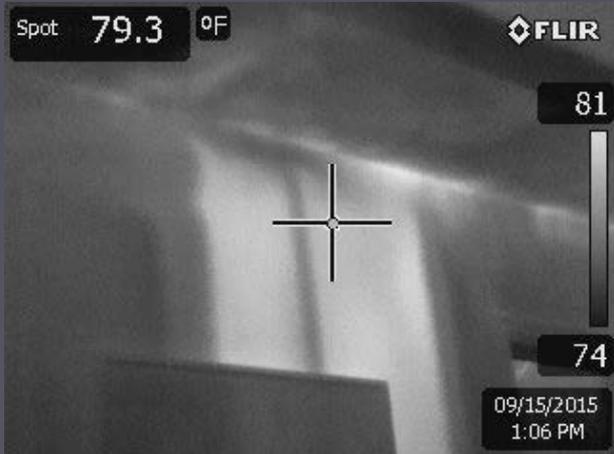
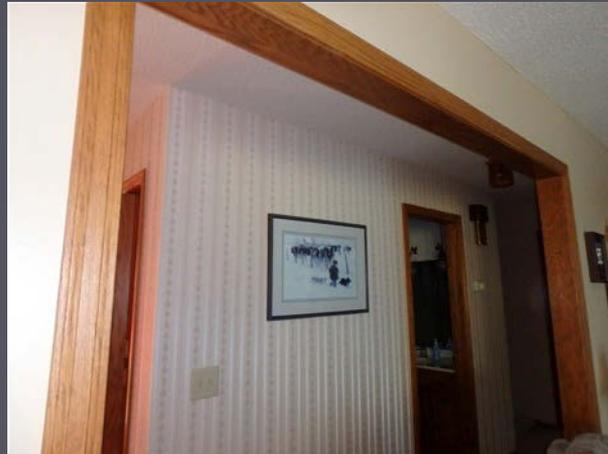
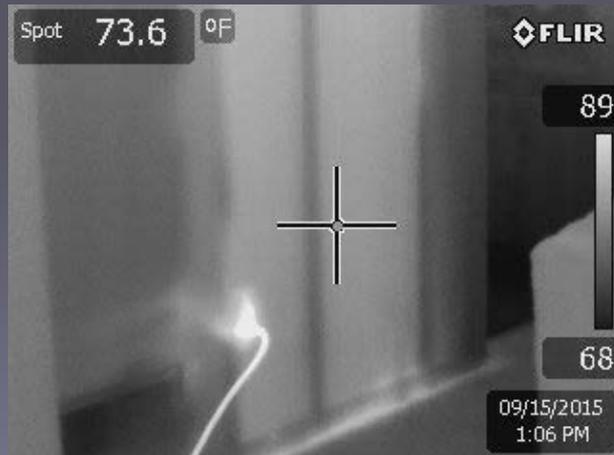
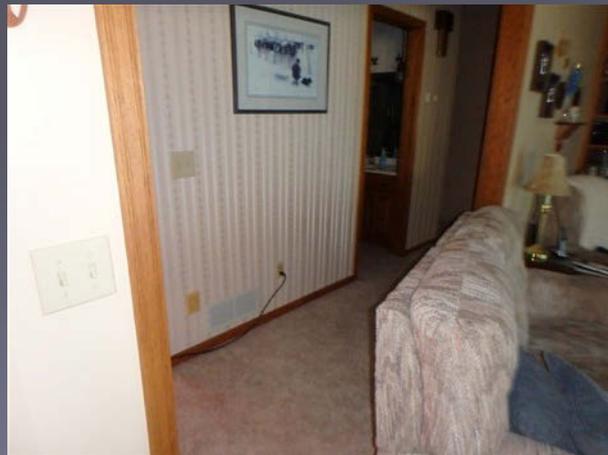
Diagnostic Pre Test

- Melt spot and ice dams

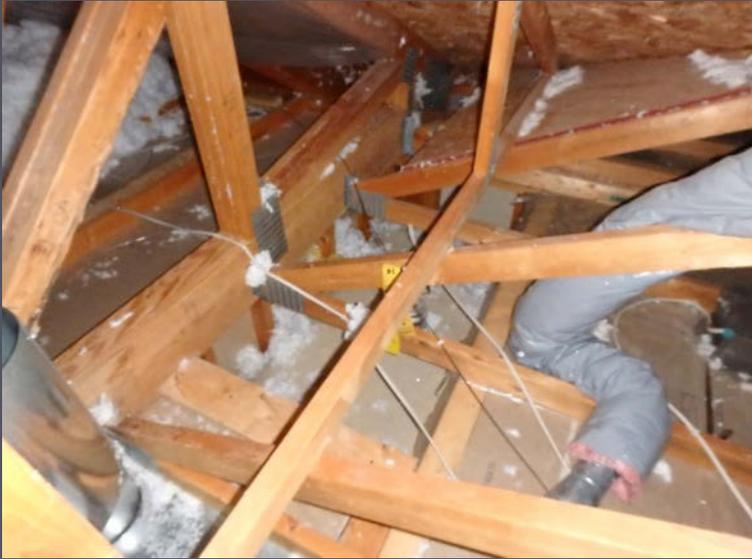
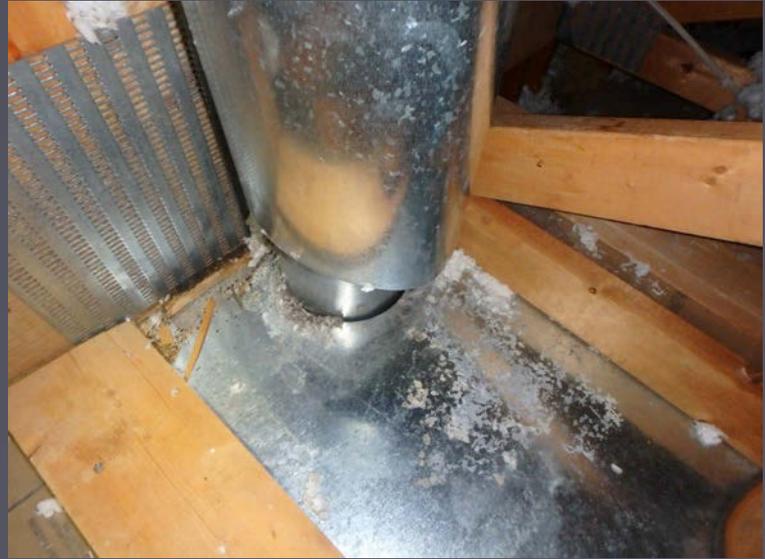
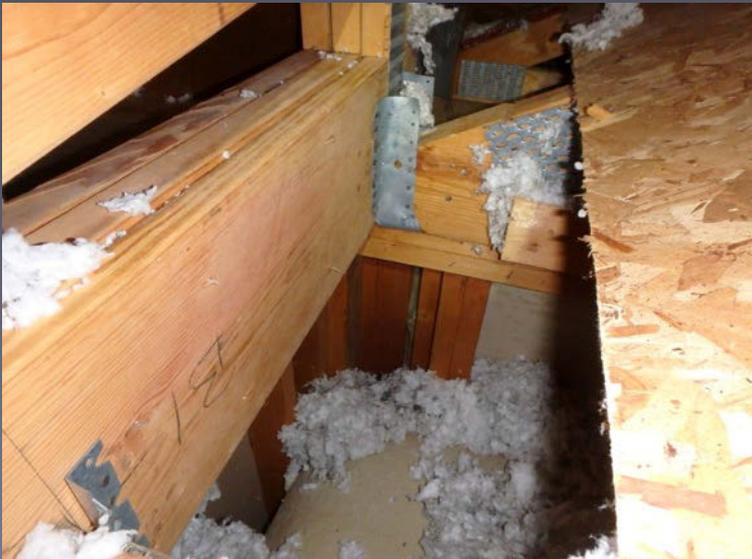
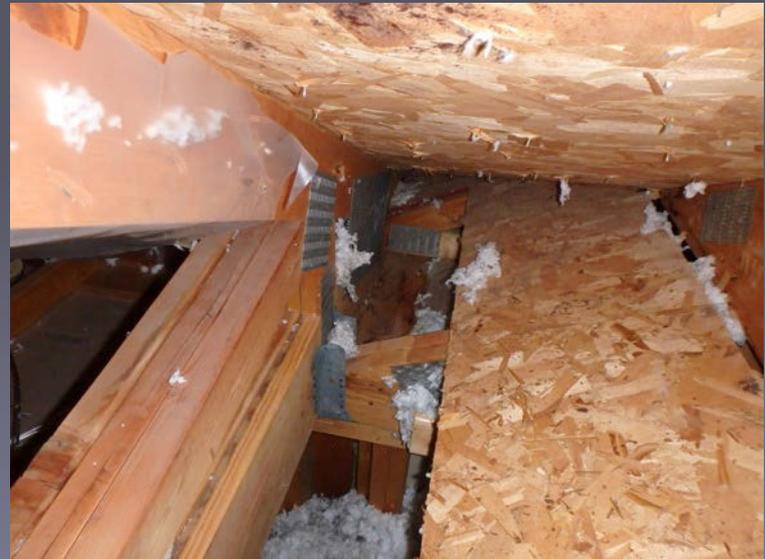
Post Test

Pre Test: $T_i = 75^\circ\text{F}$, $T_o = 82^\circ\text{F}$

Post Test: $T_i = 74^\circ\text{F}$, $T_o = 42^\circ\text{F}$

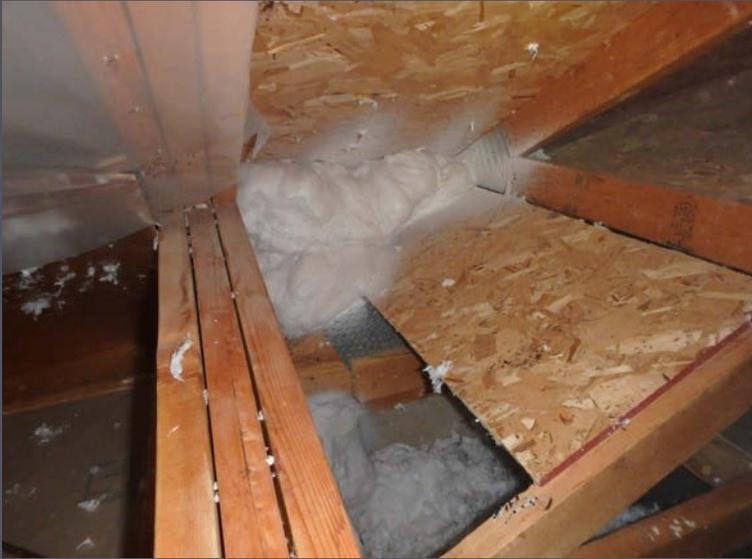
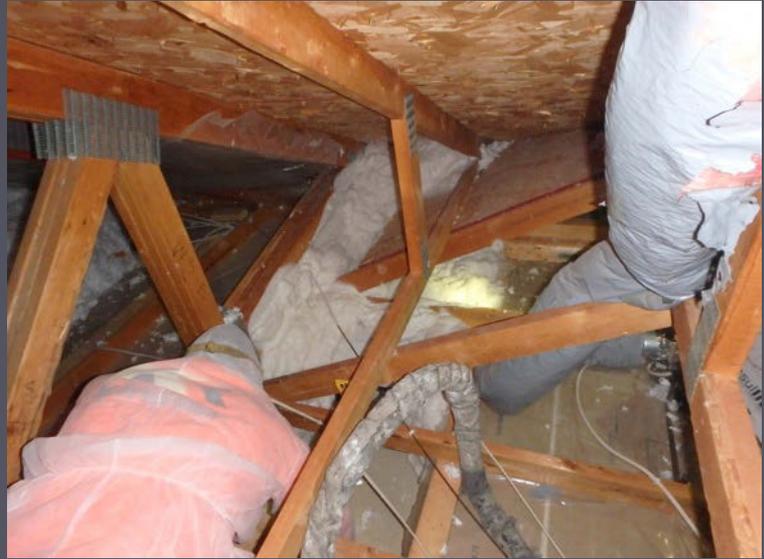
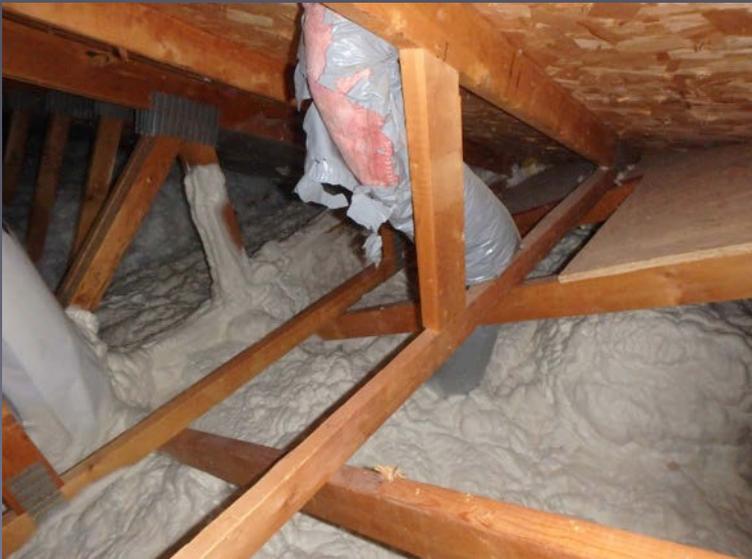
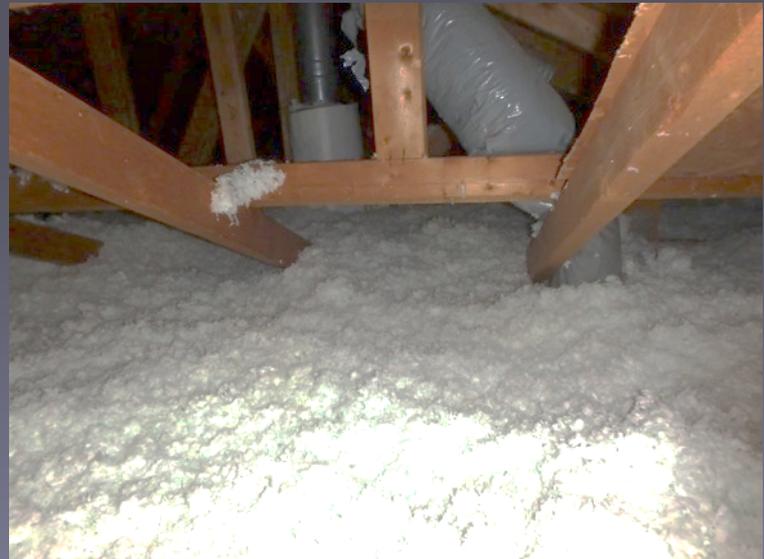
Post Test

Pre Test: $T_i = 75^\circ\text{F}$, $T_o = 82^\circ\text{F}$

Post Test: $T_i = 74^\circ\text{F}$, $T_o = 42^\circ\text{F}$

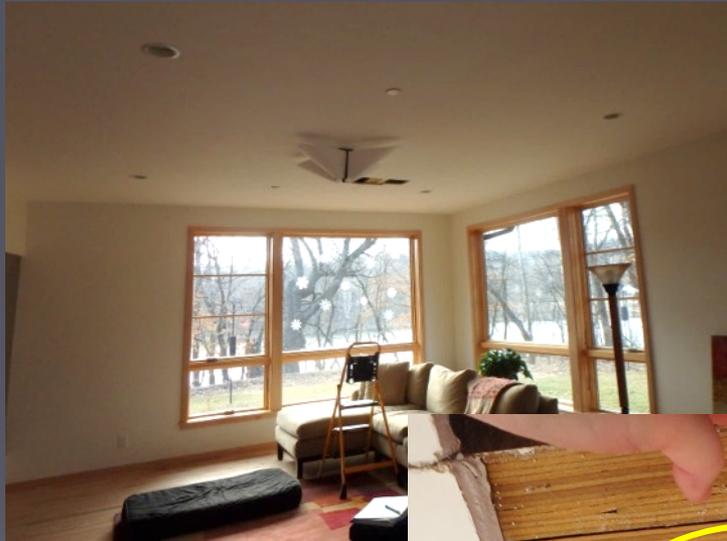
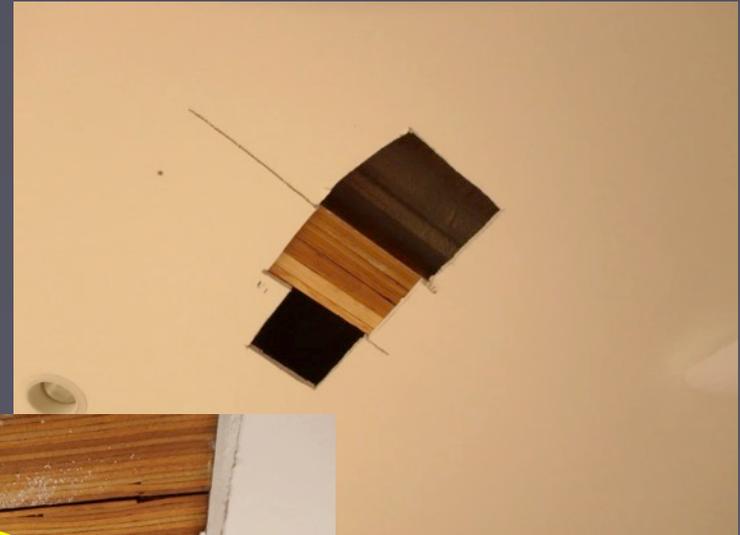
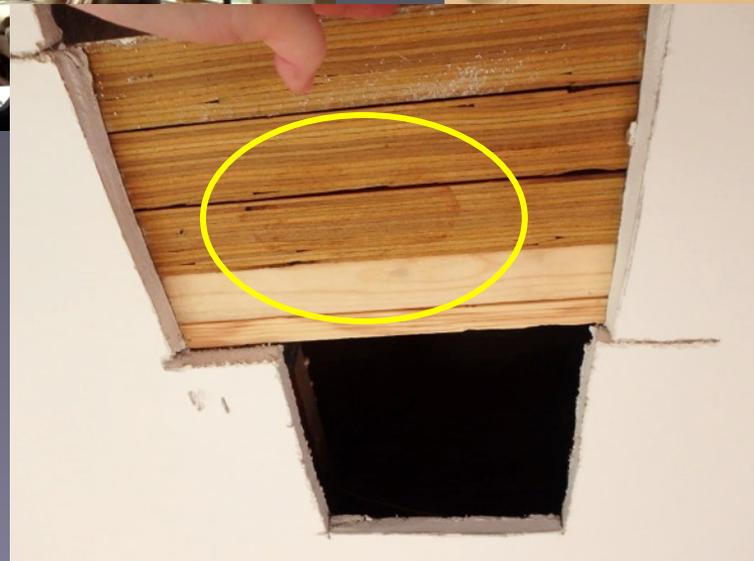
- Water dripping in main level living room ceiling
