Foundations Failures & Successes

EDC 2019

DULUTH, MINNESOTA

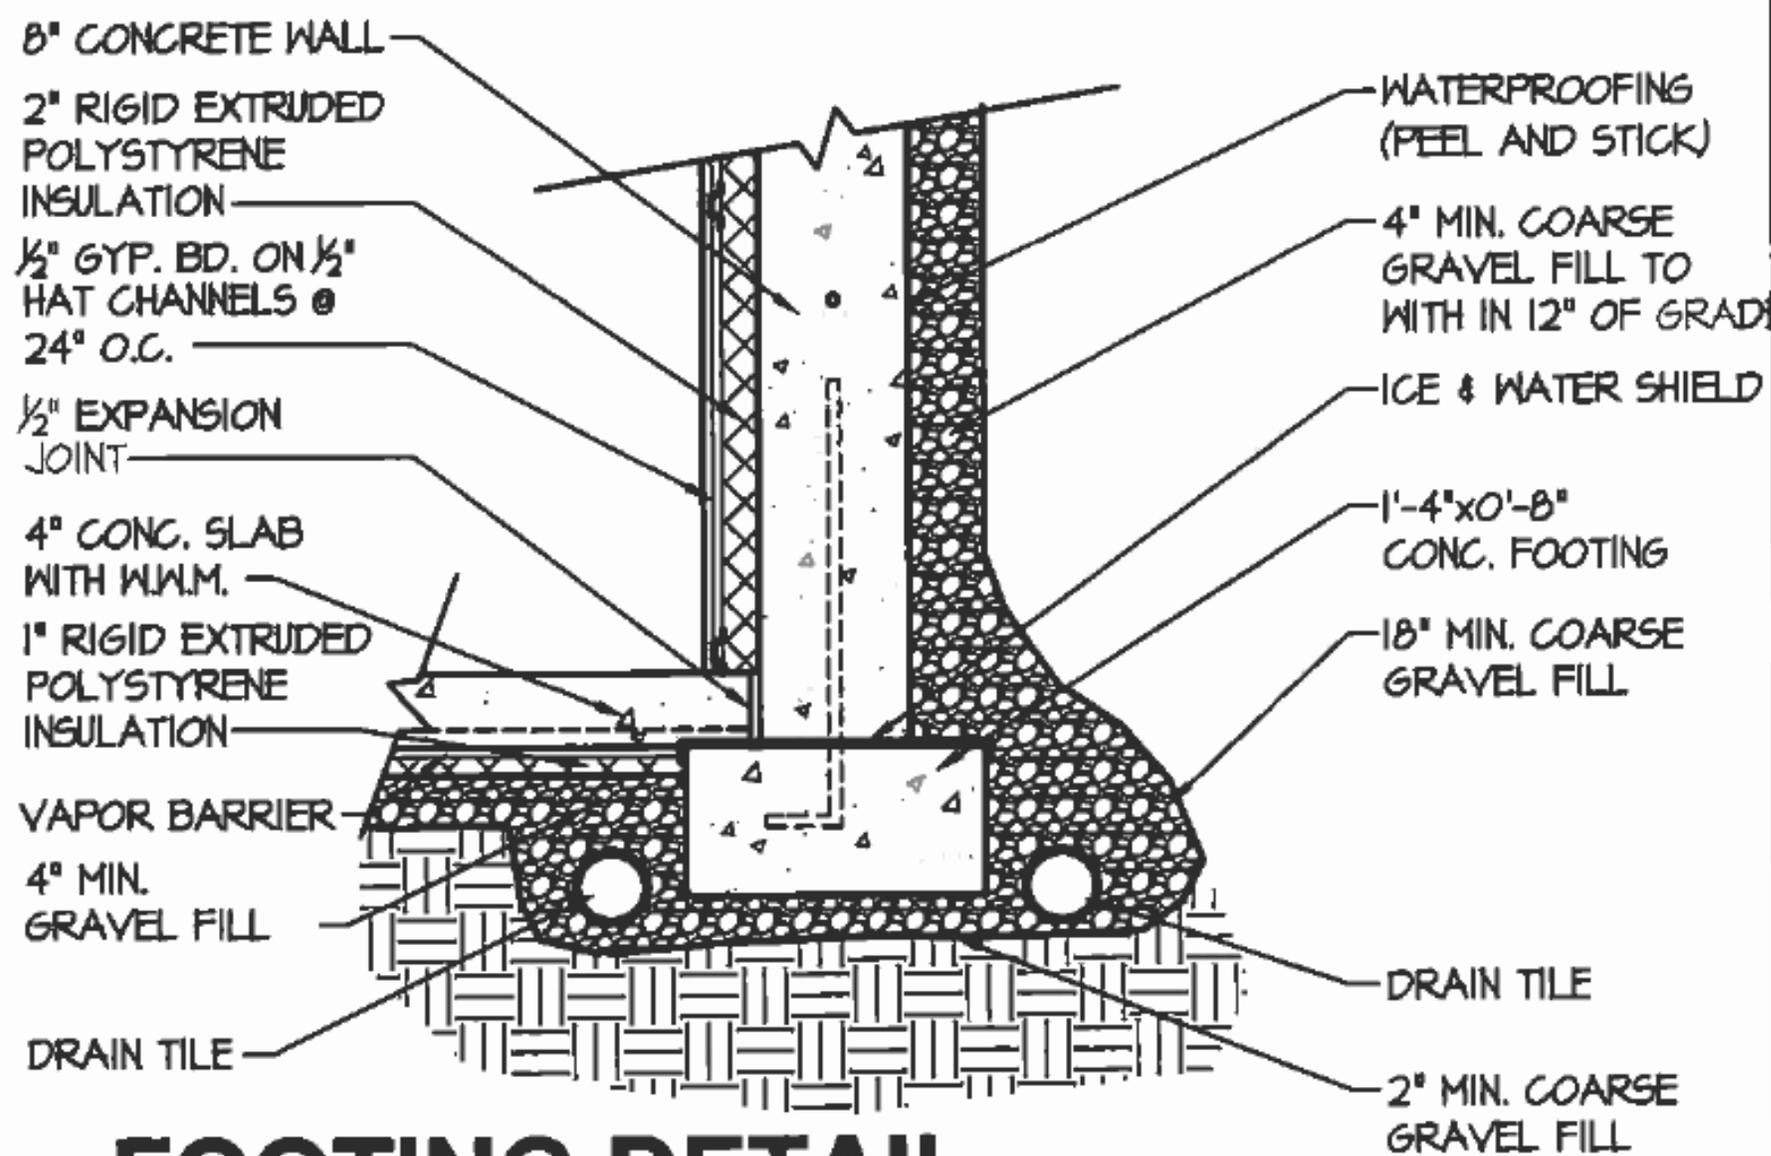
FOOTING DETAIL

SCALE: 3/4" = 1'-0"

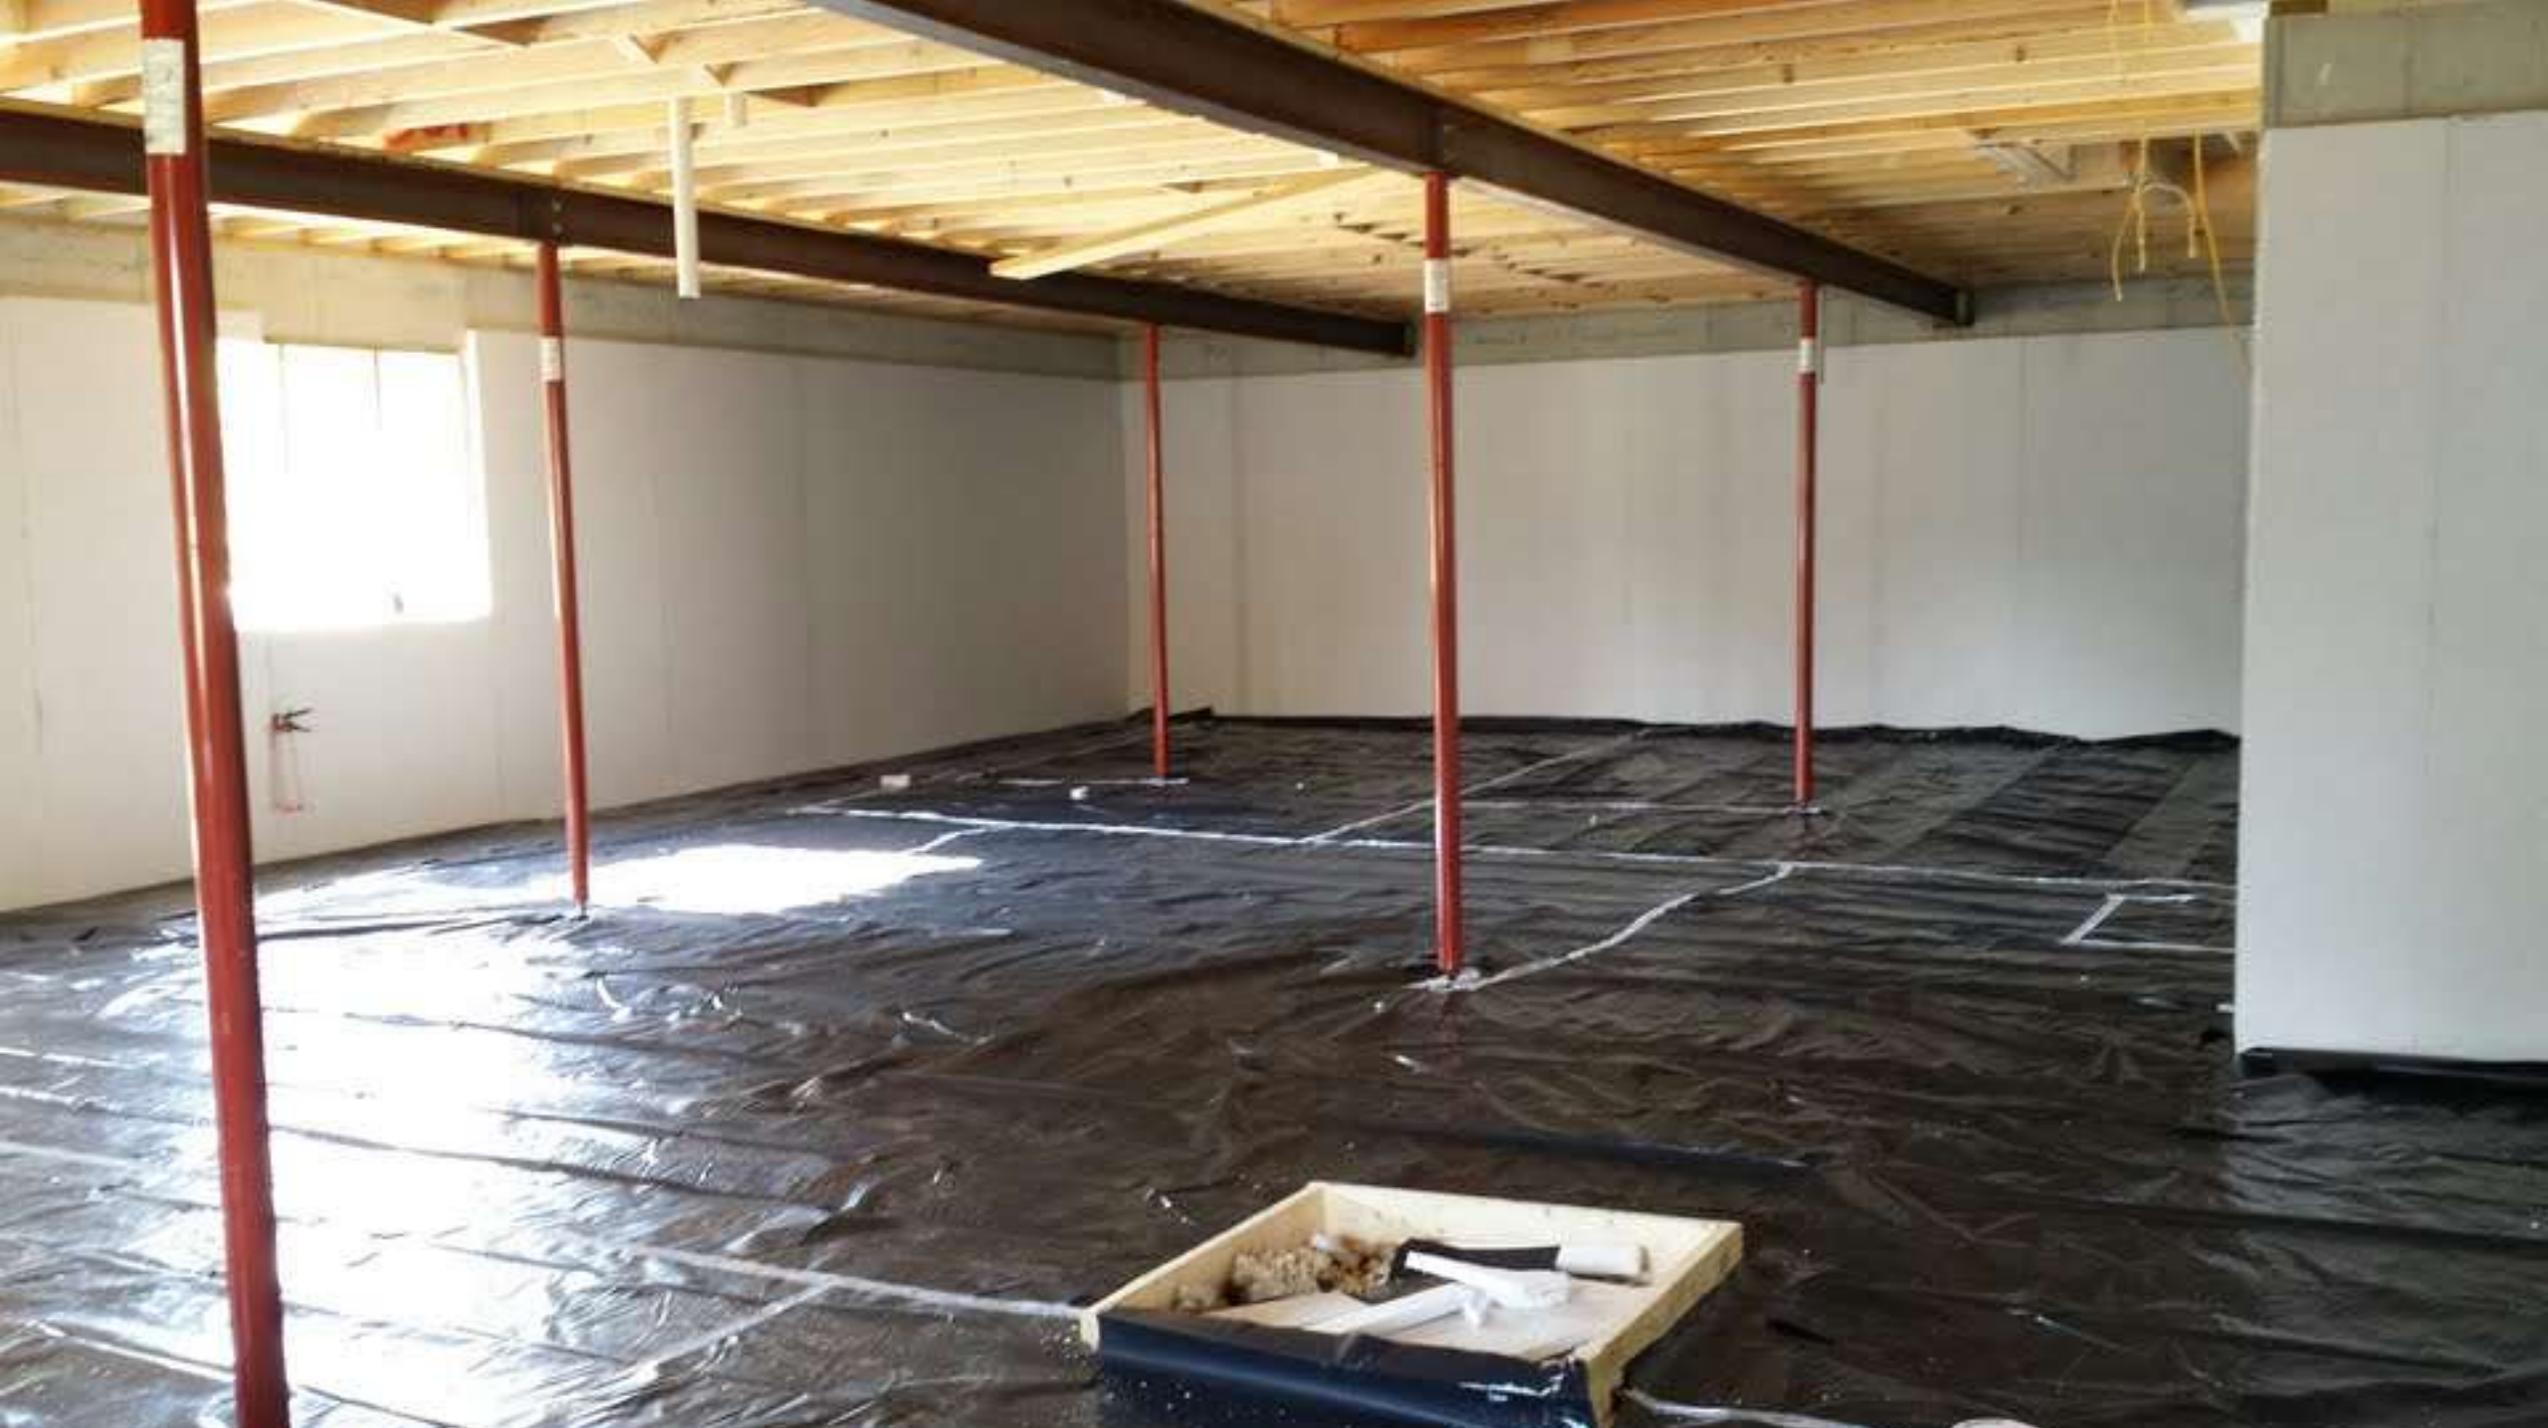
3" X 11 Gauge
Adjustable Column
8'3"-8'7"

ALLOWABLE LOAD
13000#

Conforms to ASTM A-513
and all corrosion treatment specifications.
Column should be immobilized after final adjustment
using screw thread or encasement in concrete.

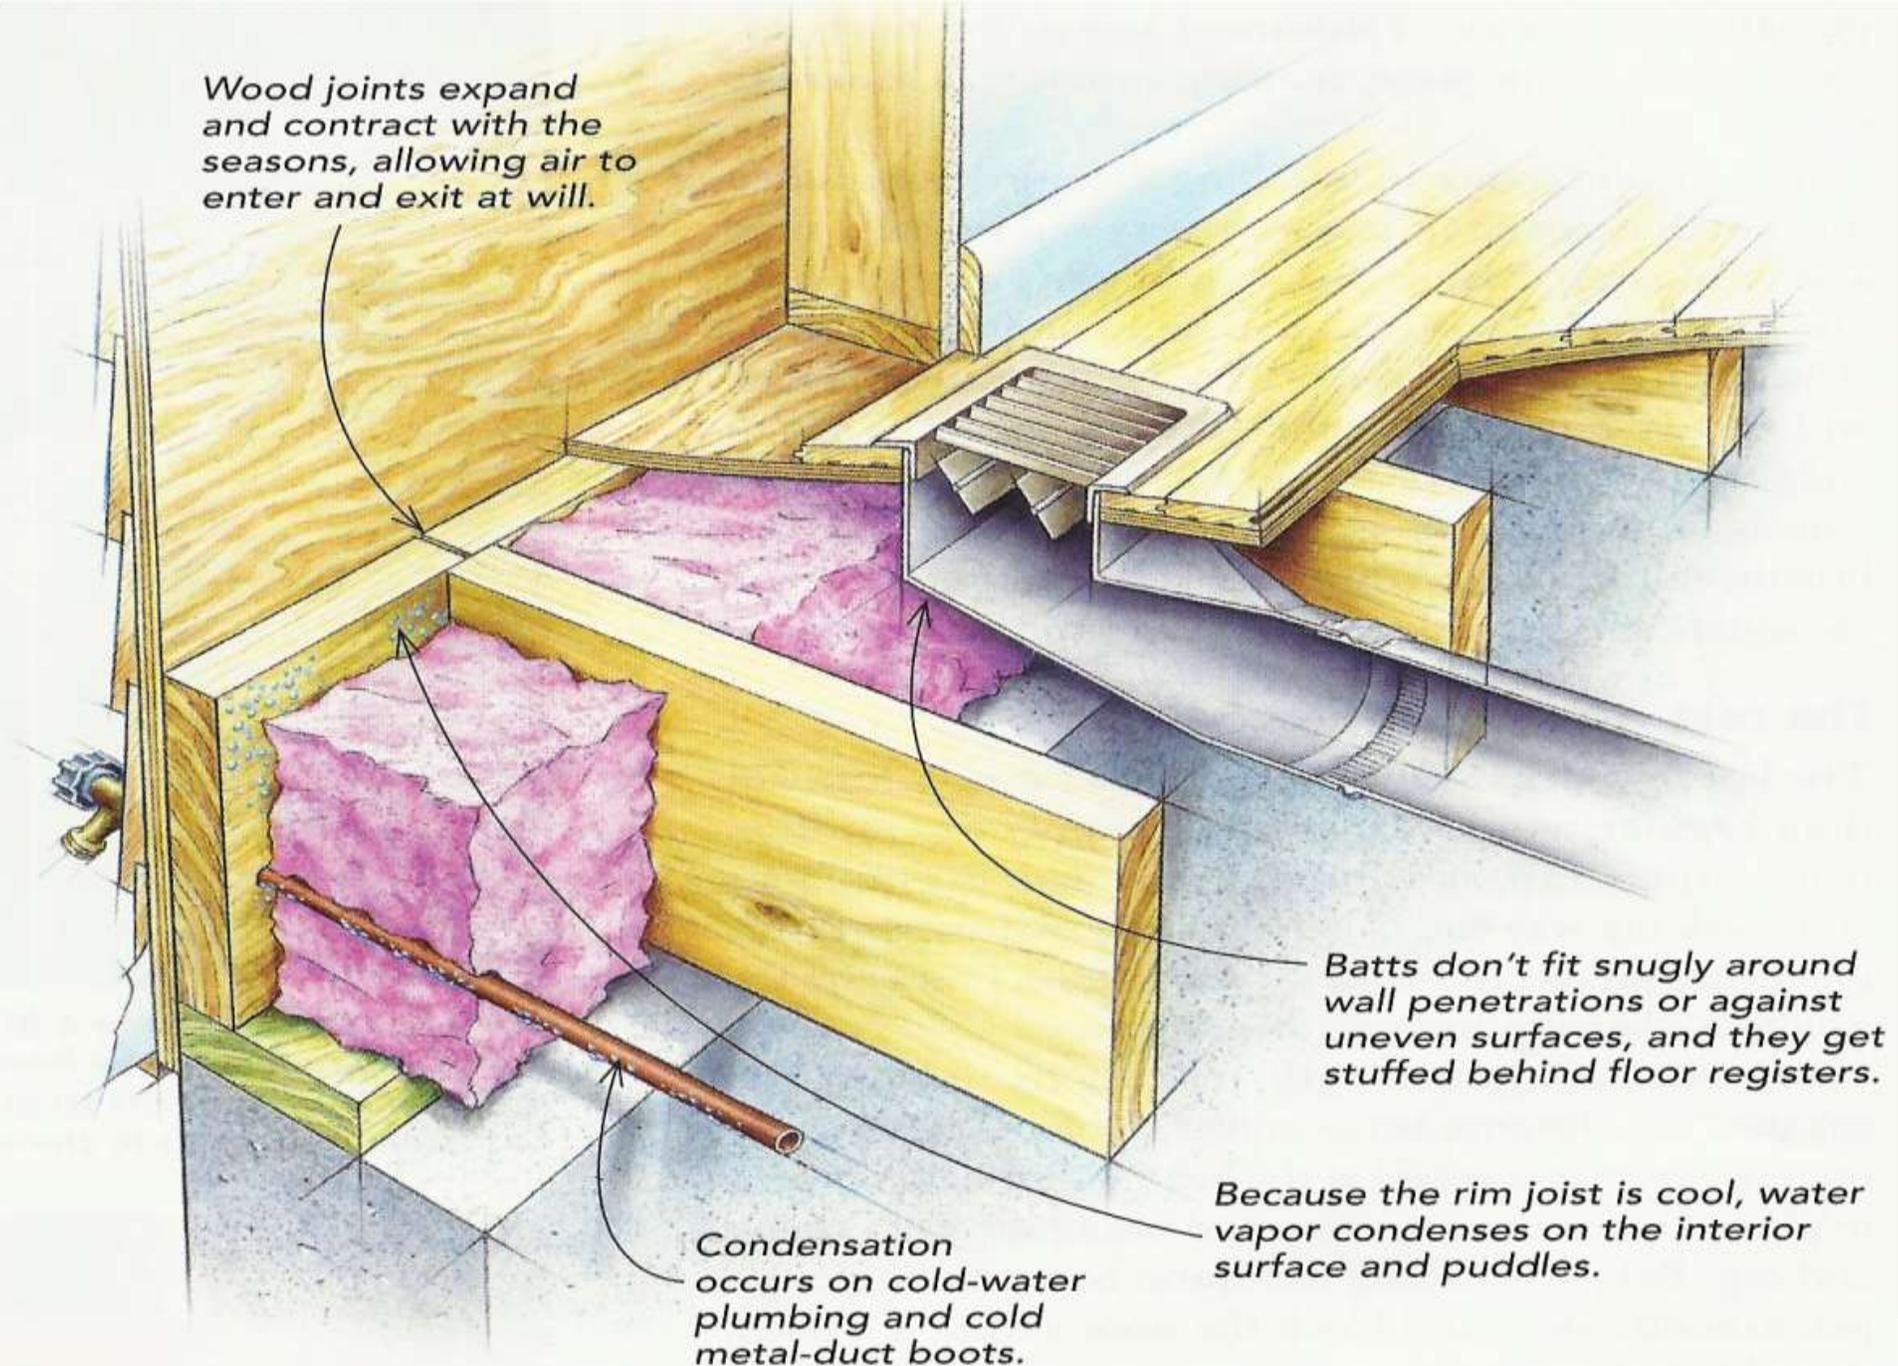
Wood joints expand and contract with the seasons, allowing air to enter and exit at will.

Batts don't fit snugly around wall penetrations or against uneven surfaces, and they get stuffed behind floor registers.

Because the rim joist is cool, water vapor condenses on the interior surface and puddles.

Condensation occurs on cold-water plumbing and cold metal-duct boots.

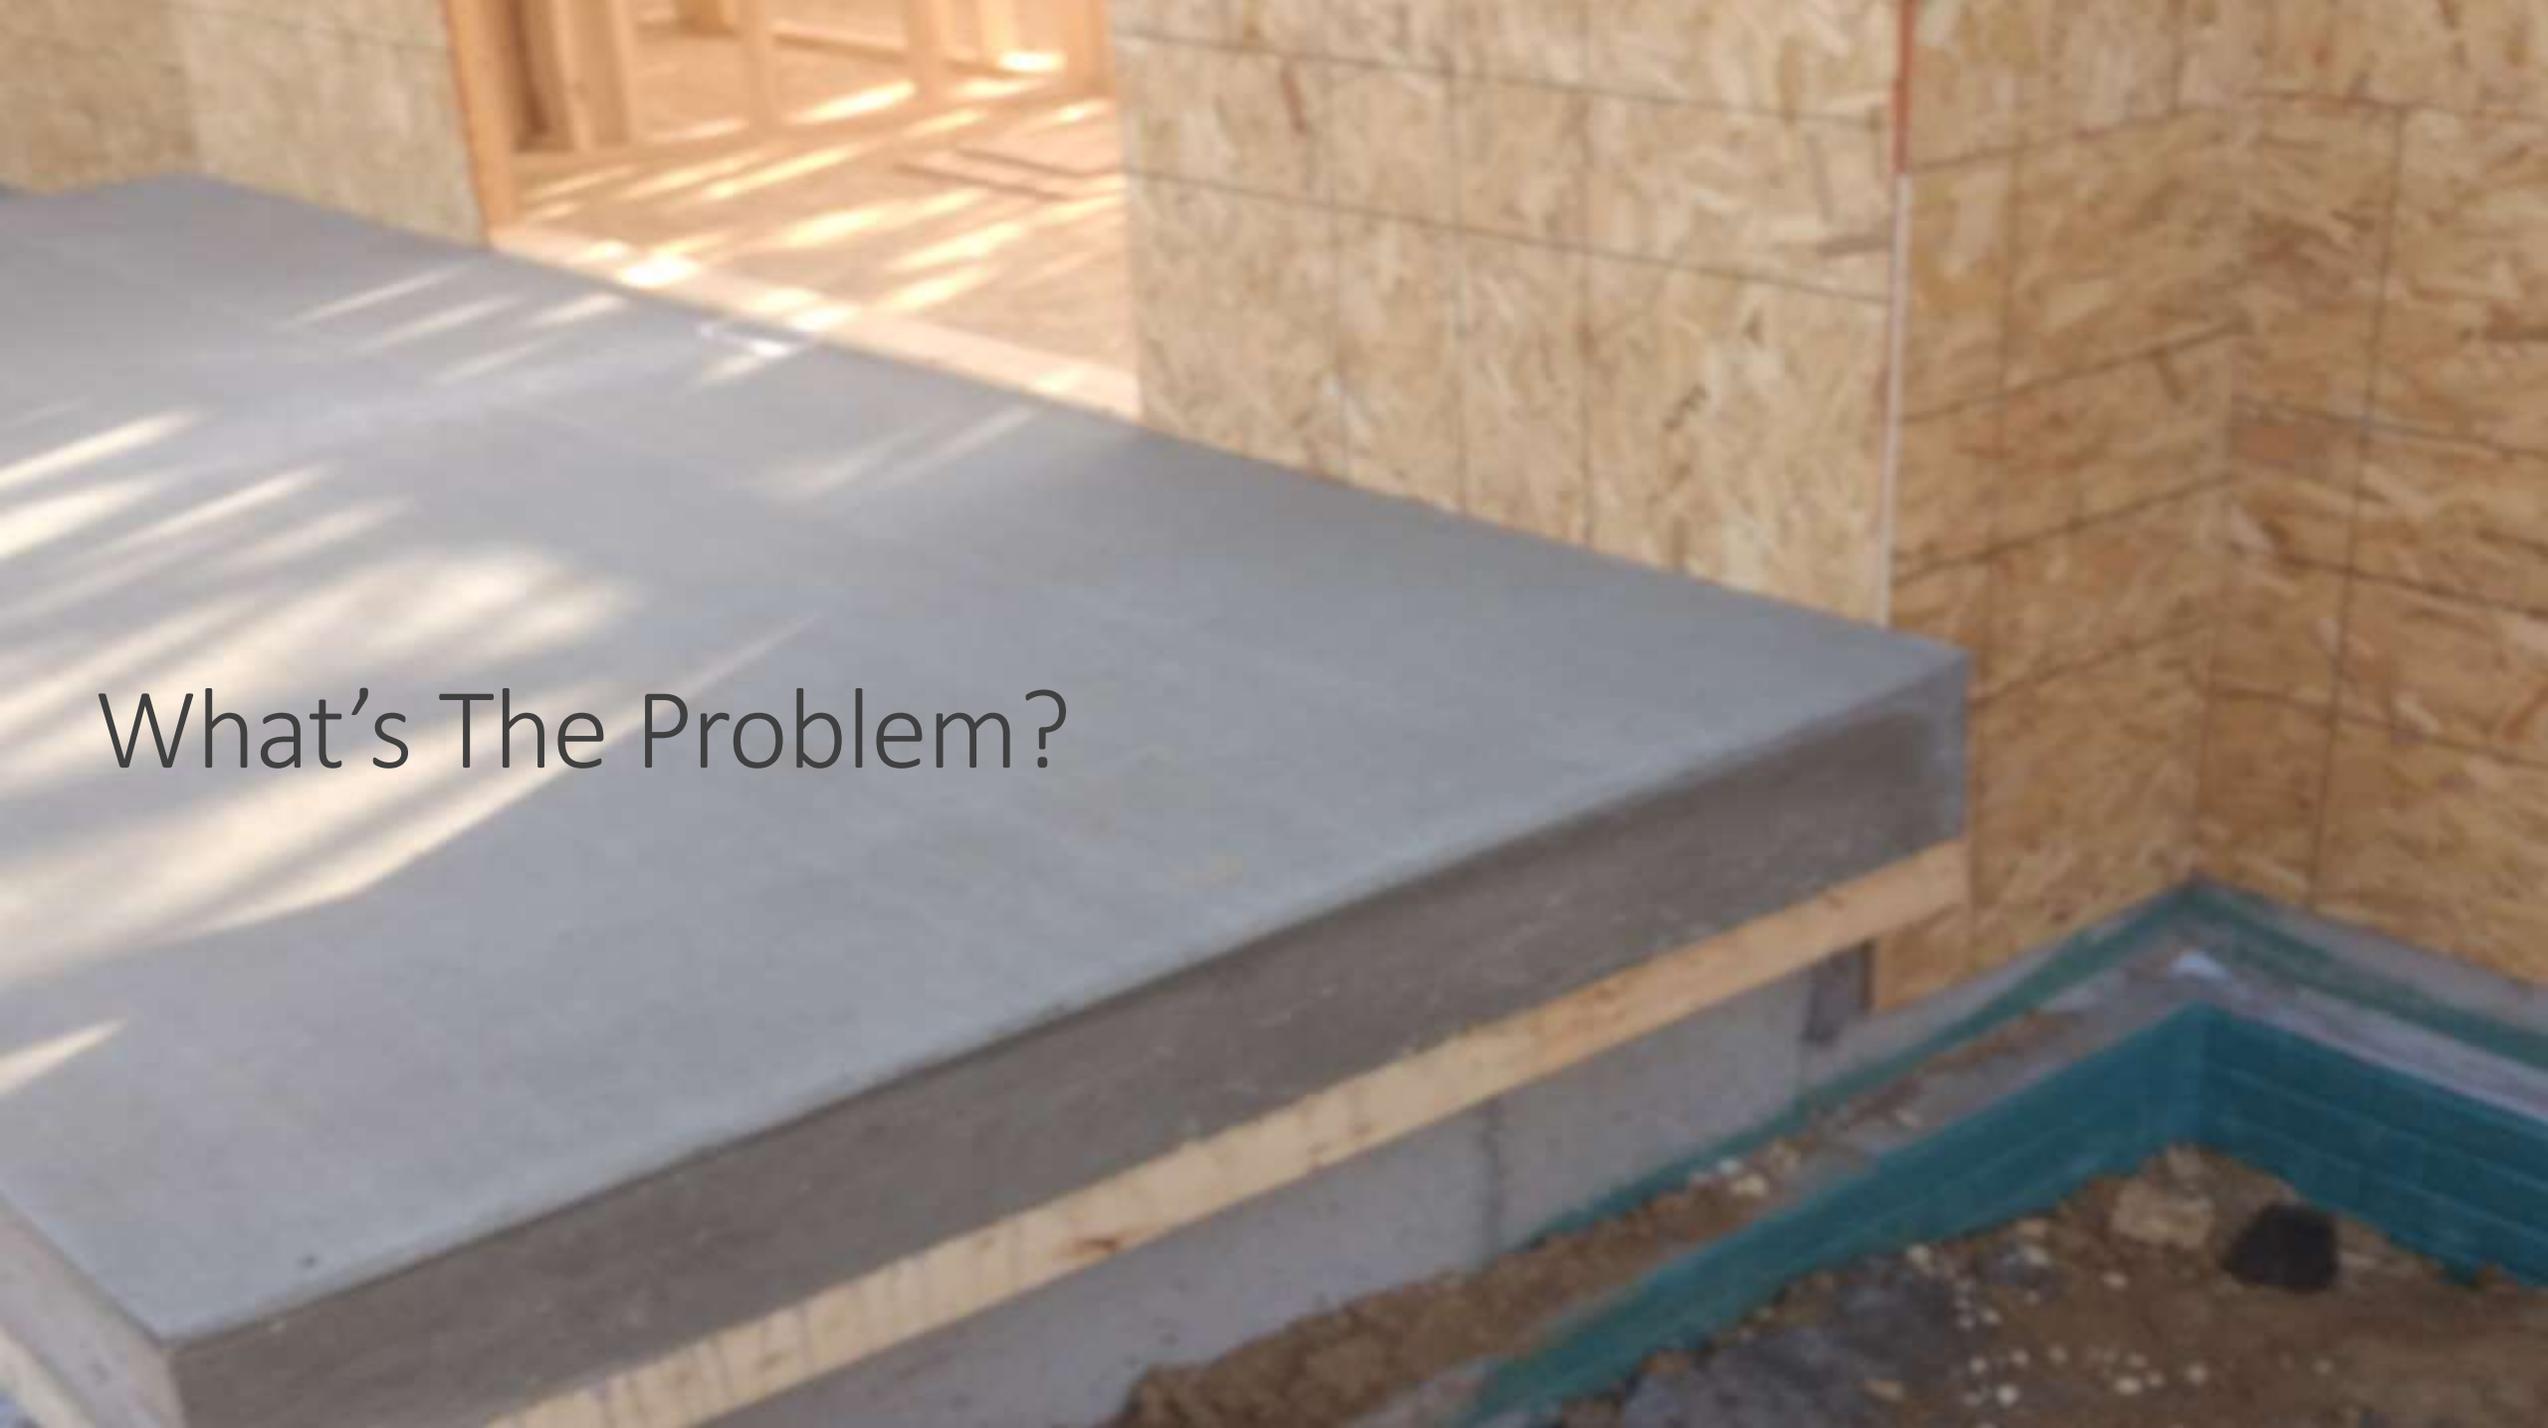
What's The Problem?

A construction site showing a concrete slab on a wooden formwork, with a blue drainage channel in the foreground and OSB walls in the background. The concrete slab is a uniform grey color and is supported by a wooden frame. The walls are made of oriented strand board (OSB) panels. In the foreground, there is a blue drainage channel with a black cap. The floor is covered with gravel and dirt. The text "What's The Problem?" is overlaid on the image.
