February 7, 2025

**VIA E-FILING**

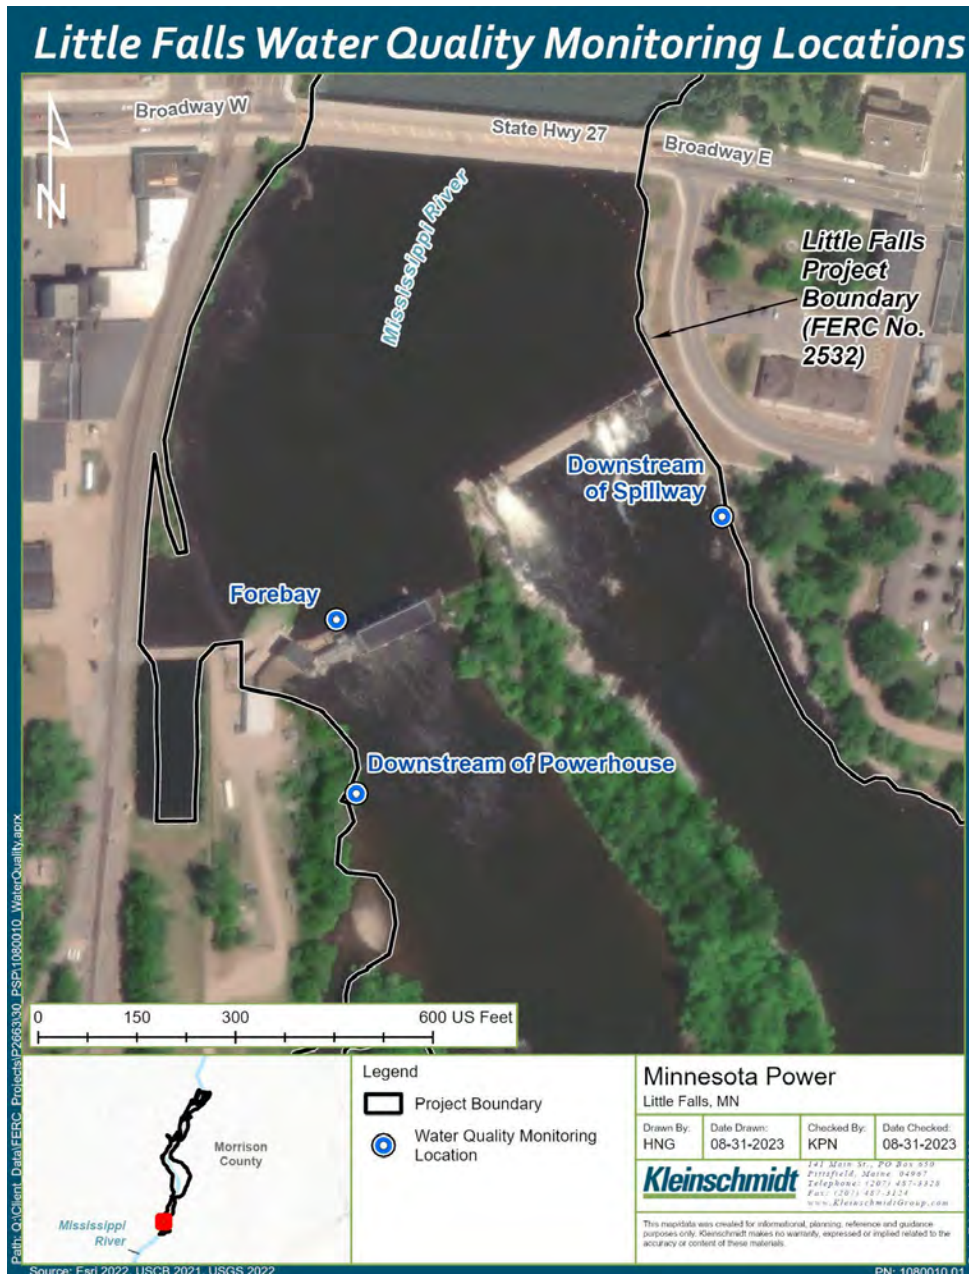
These three sampling locations match the locations identified in the FERC approved RSP (2024). The stations include conditions representative of slower pool and flowing channel conditions. The Forebay location is characterized as a pool habitat, while the Downstream of Spillway corresponds with conditions of a run, and the Downstream of Powerhouse location is characteristic of a riffle.

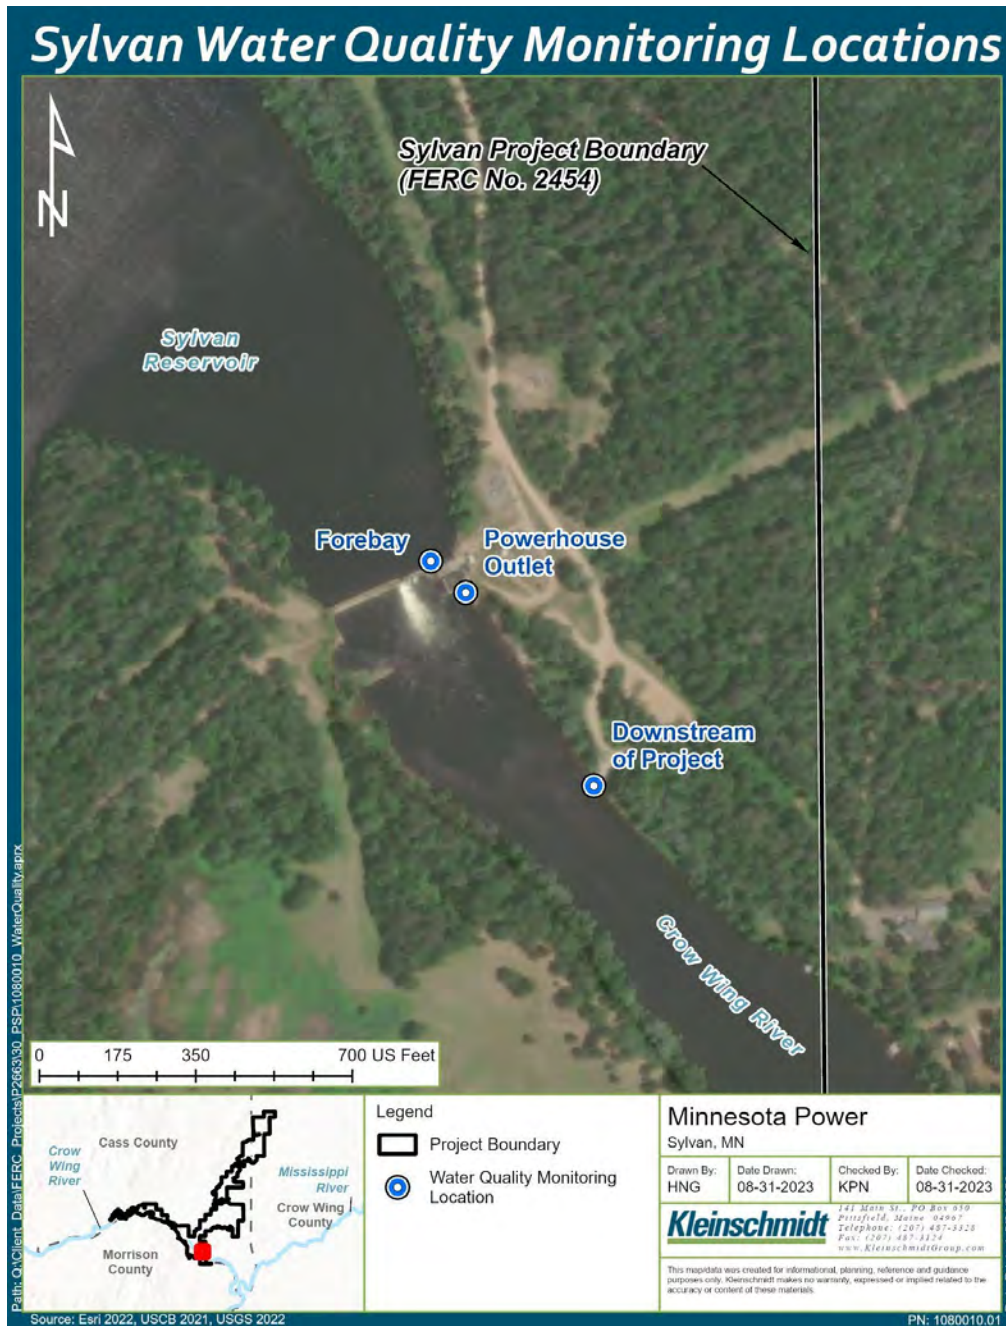
These three sampling locations match the locations identified in the FERC approved RSP (2024). The stations include conditions representative of slower pool and flowing channel conditions. The Forebay location is characterized as a pool habitat, while the Powerhouse Outlet corresponds with conditions of a run, and the Downstream of Project location corresponds with riffle conditions.

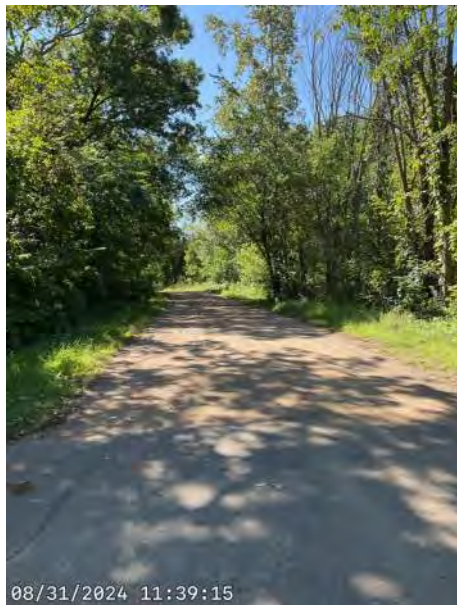
Date: 2024-12-19  
Location: 46.3266°, -94.4115°  
Description: Access road

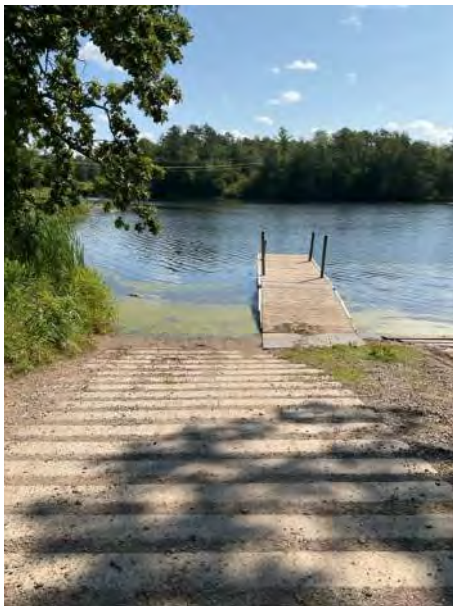
Date: 2024-12-19  
Location: 46.3108°, -94.3836°  
Description: Public Access Boat launch

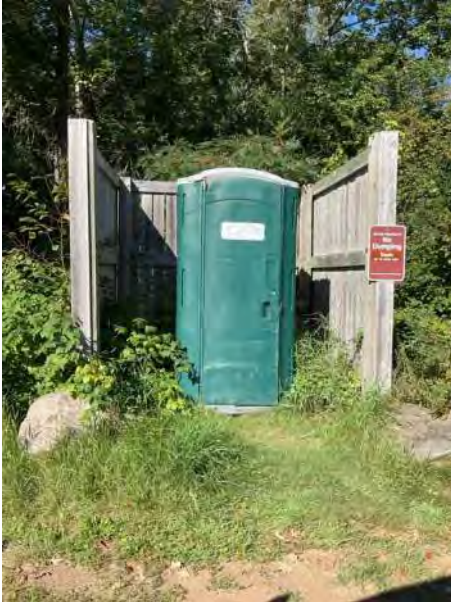
Date: 2024-12-19  
Location: 46.3112°, -94.3839°  
Description: Portable restroom  
Photo Type: RR

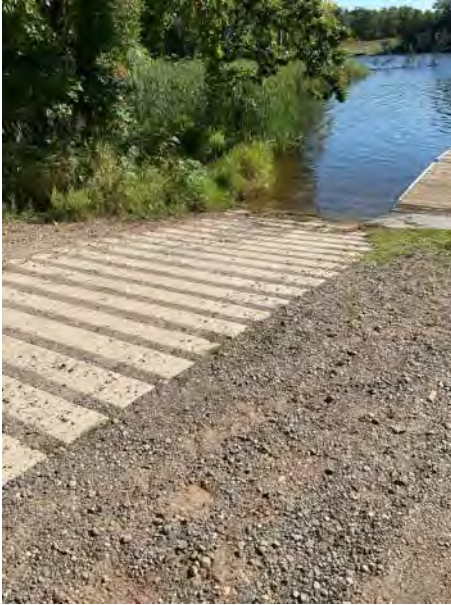
Date: 2024-12-19  
Location: 46.3108°, -94.3835°  
Description: North launch  
Photo Type: BL

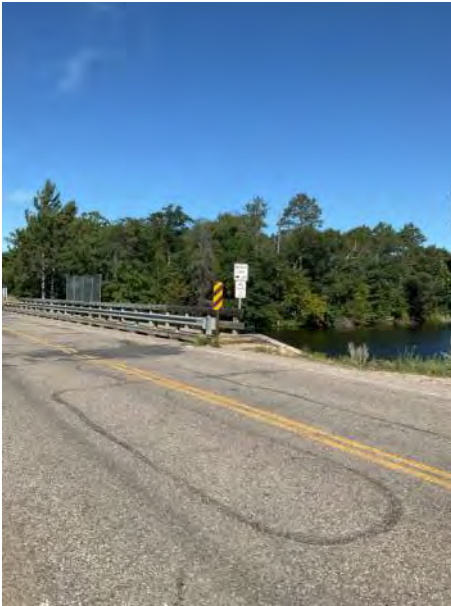
Date: 2024-08-31  
Location: 46.3118°, -94.3808°  
Description: No diving sign  
Photo Type: SS

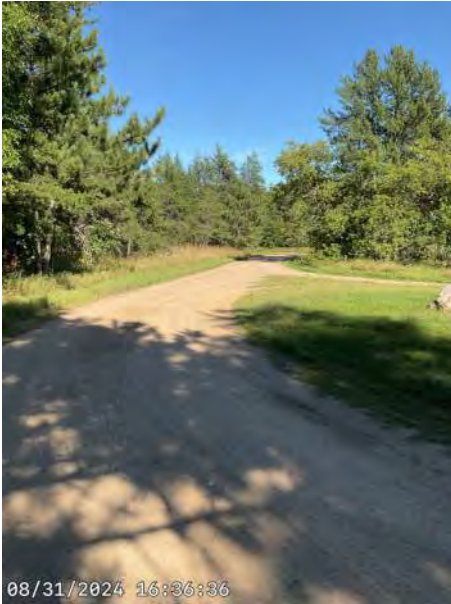
Date: 2024-08-31  
Location: 46.3173°, -94.4867°  
Description: Access road from the parking lot

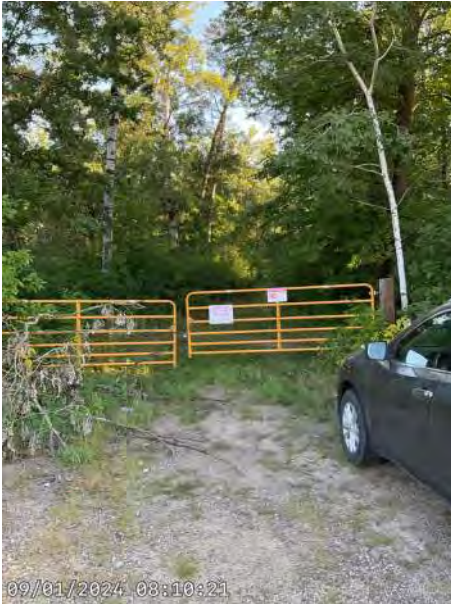
Date: 2024-09-01  
Location: 46.3114°, -94.4835°  
Description: Parking area near the road

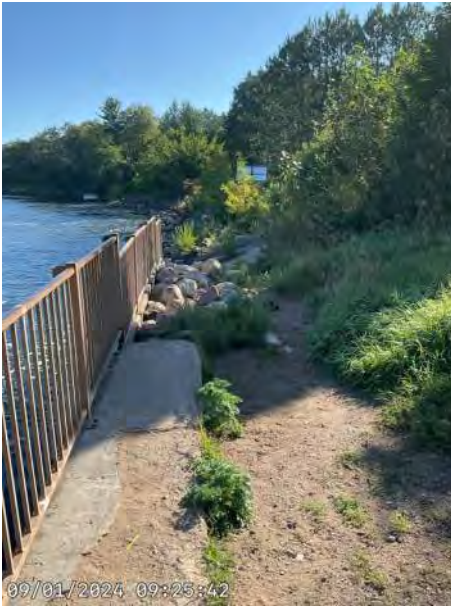
Date: 2025-01-28  
Location: 46.3151°, -94.4841°  
Description: Shore fishing area  
Photo Type: FP
