Case Study 3

- Minneapolis, MN
- 1924 with remodels

Pain

Water intrusion

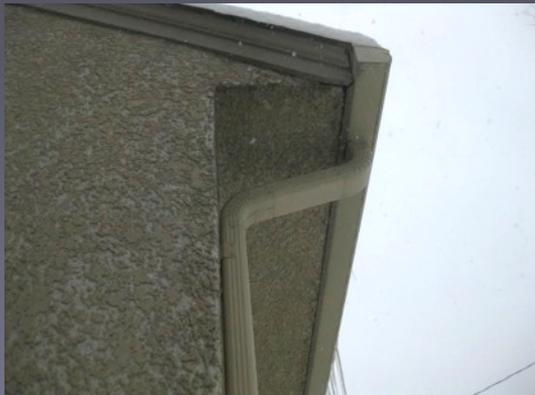
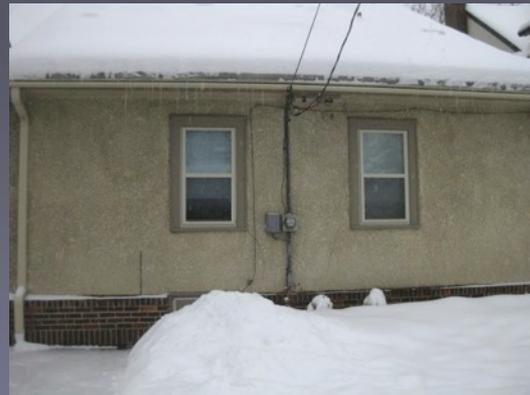
- Homeowner Goal: Stop water intrusion and ice dams
- House Needs:
 - Consistent thermal and pressure boundaries
- Constraints
 - Limited opportunity for attic ventilation
 - Unknown side attic and knee wall conditions
 - Unknown vault assembly including R-value and venting

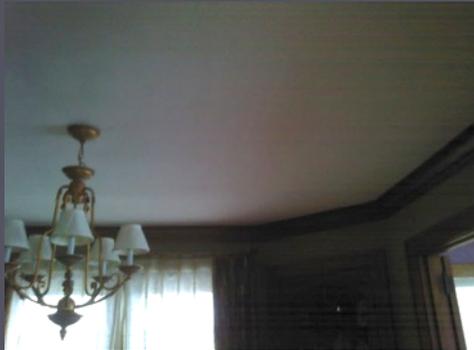
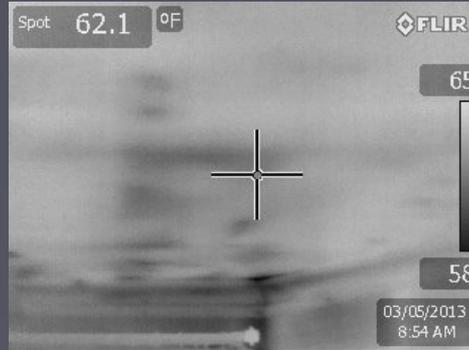
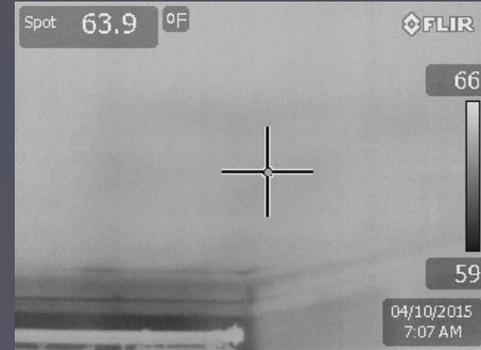
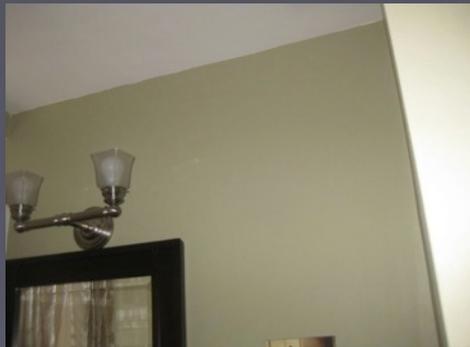
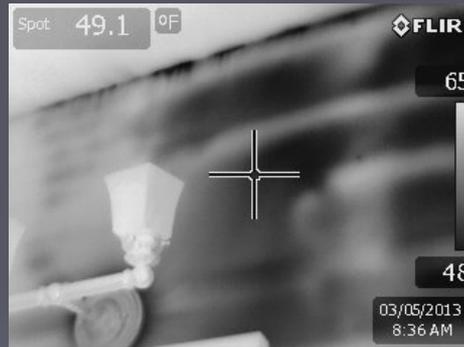
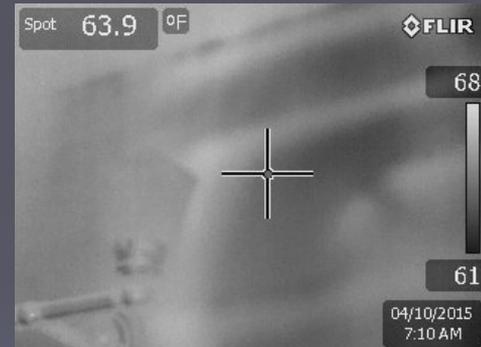
Post Test

- Pre Test: 2417 CFM50, 6.63 ACH50
- Post Test: 1765 CFM50, 4.85 ACH50

Difference: -652 CFM50, 1.78 ACH50, 27%

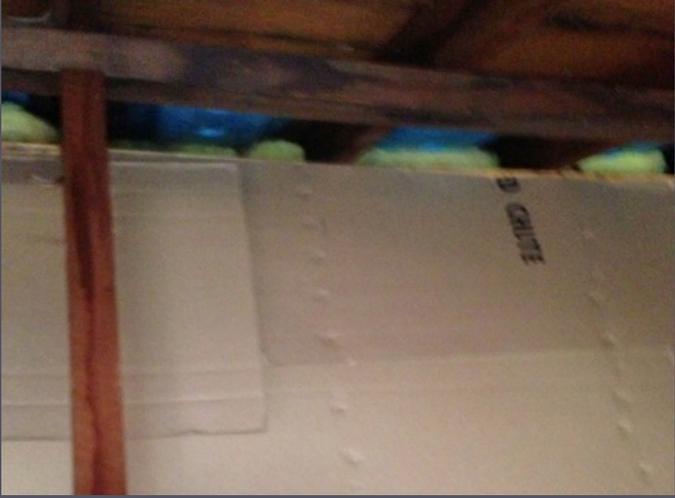
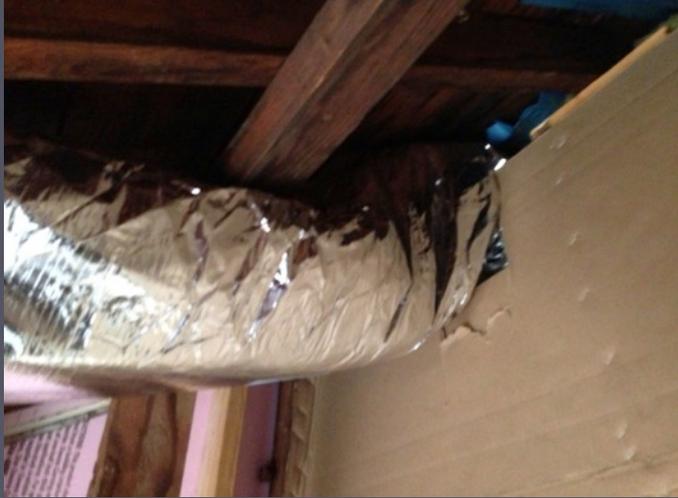
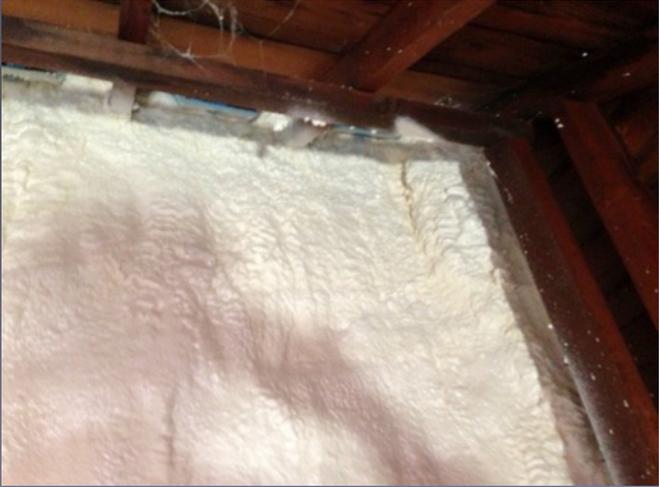
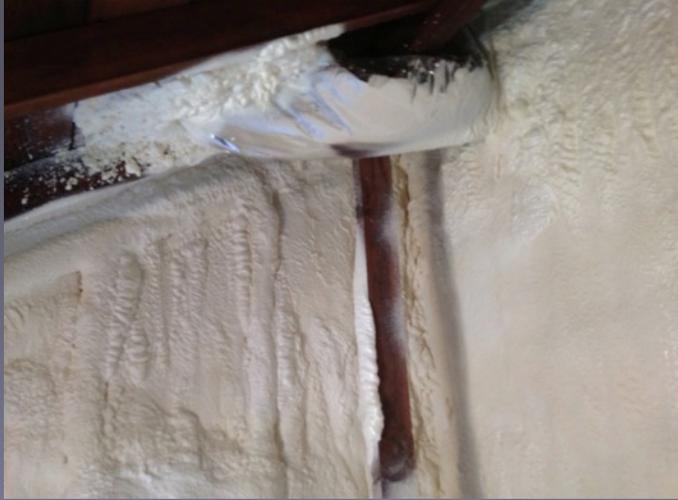
Remember this knee wall?

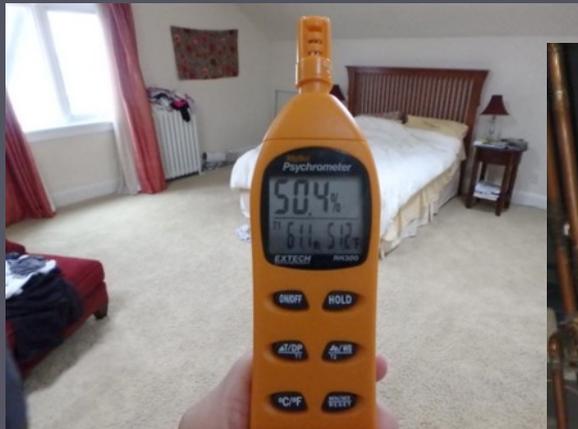
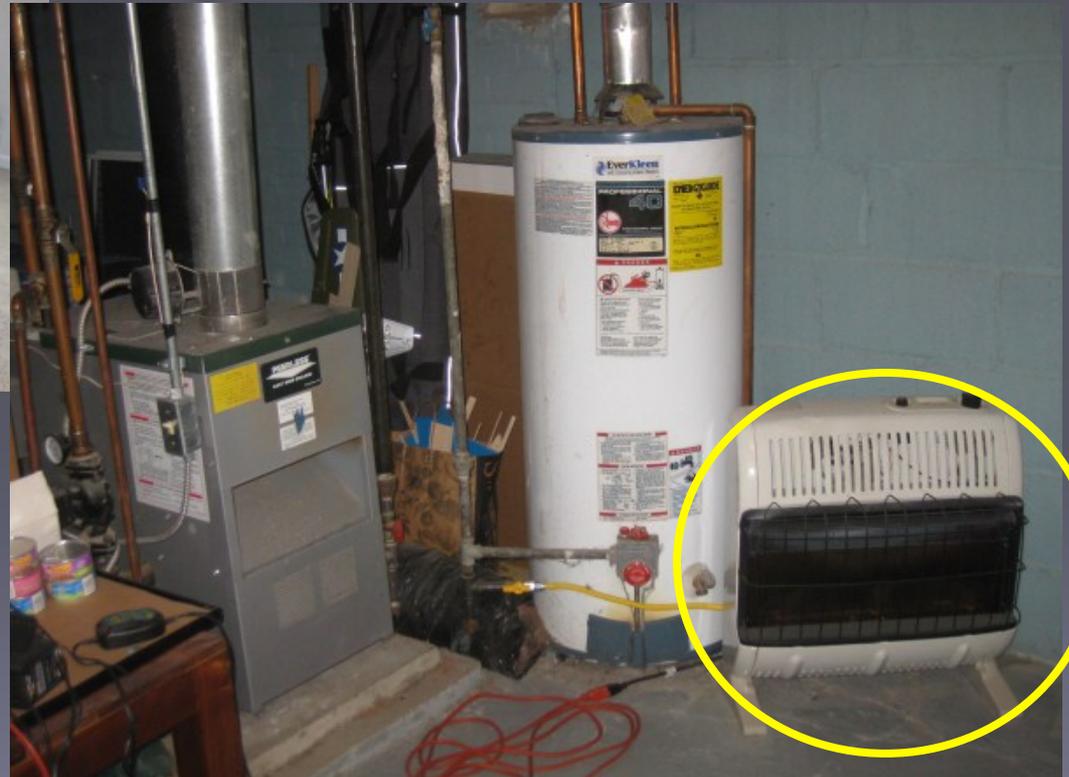
This doesn't help either...

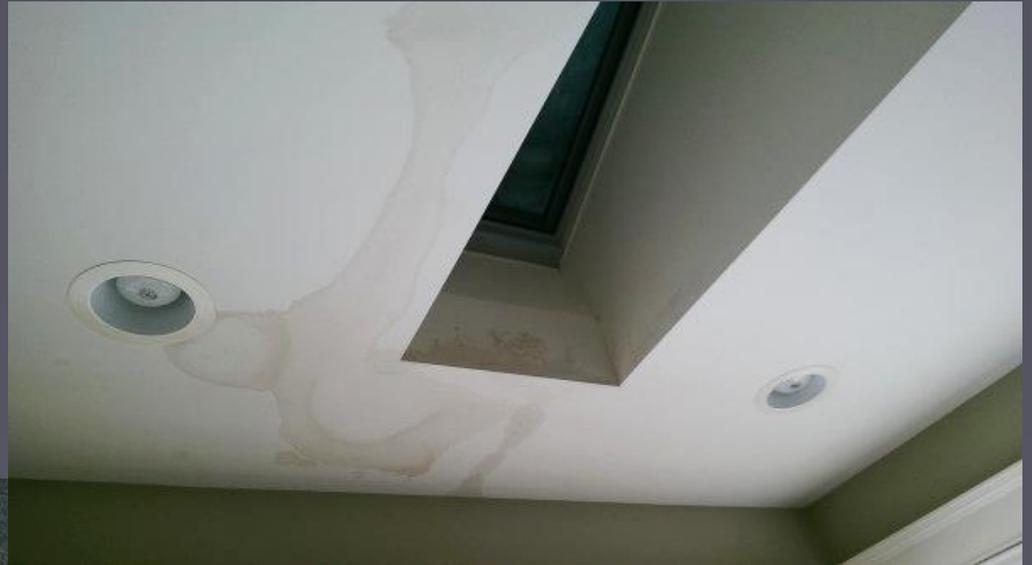
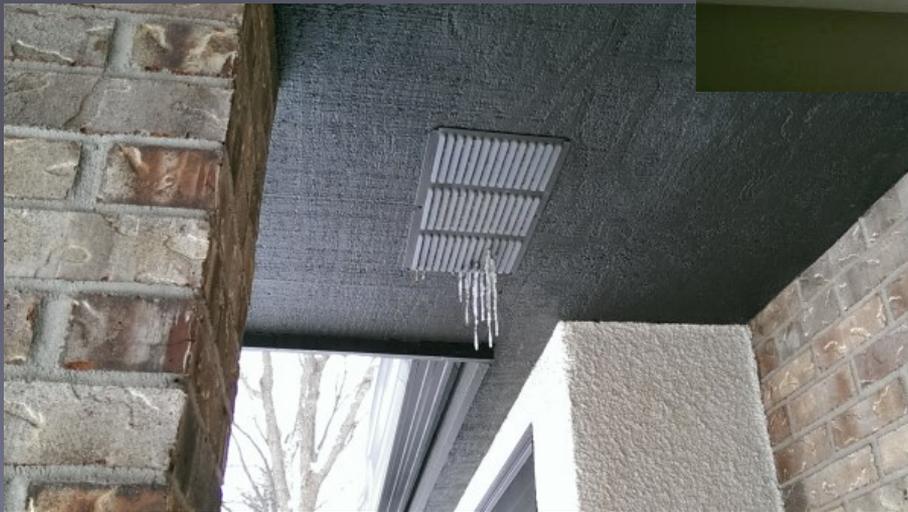
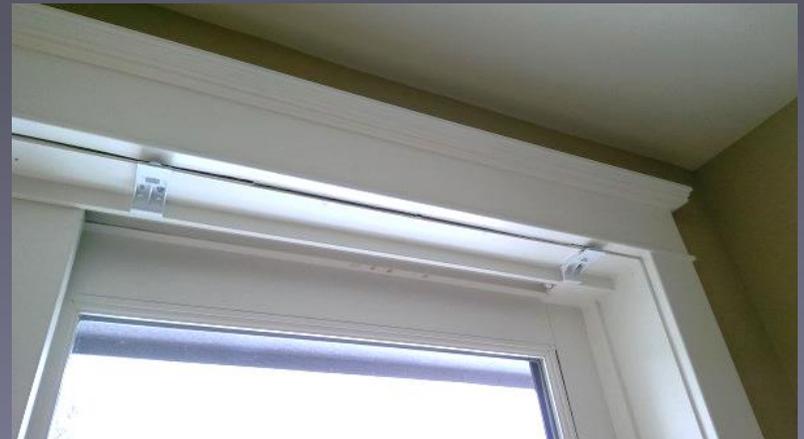
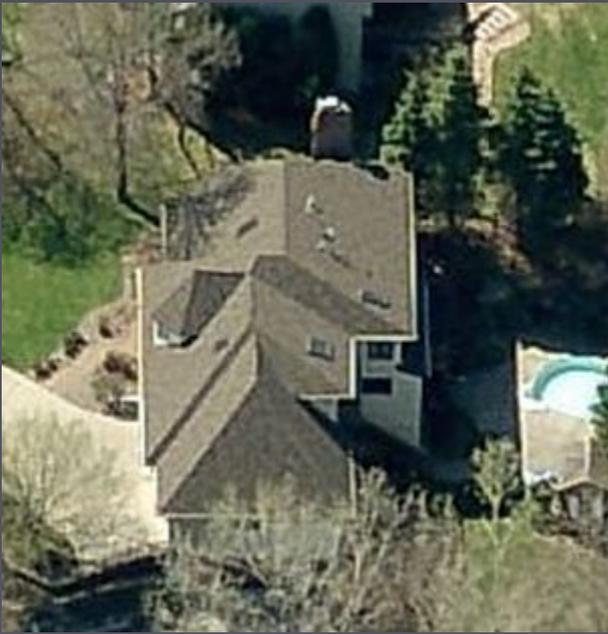
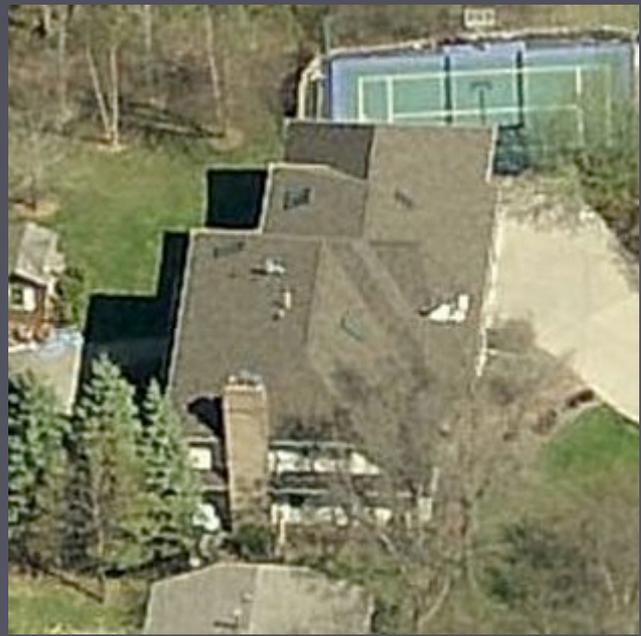
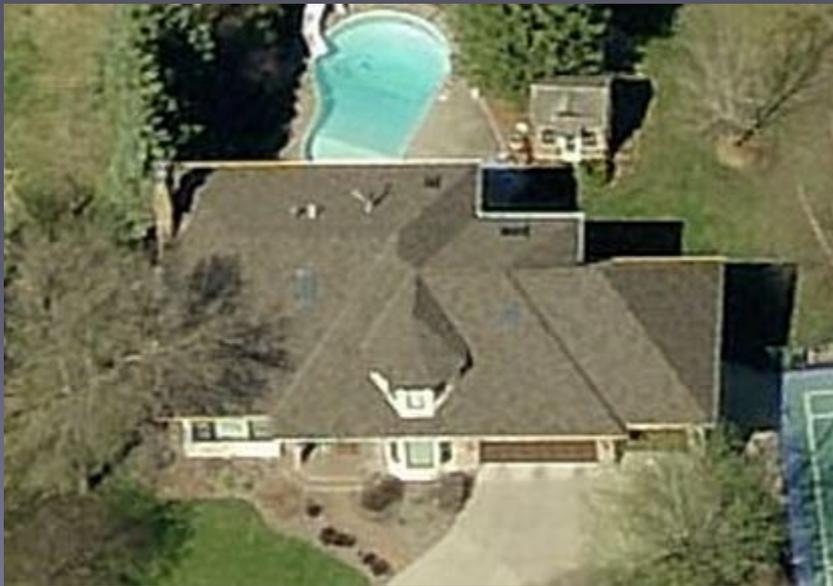
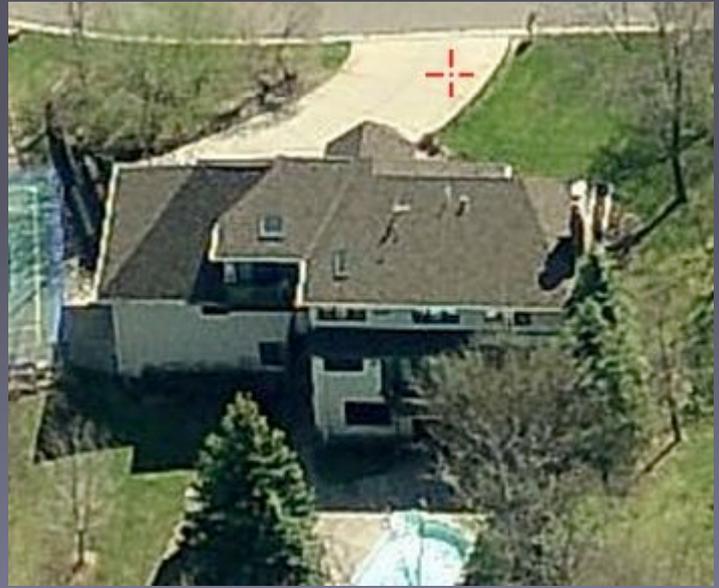
Pain

- Ice dams
- Water Intrusion

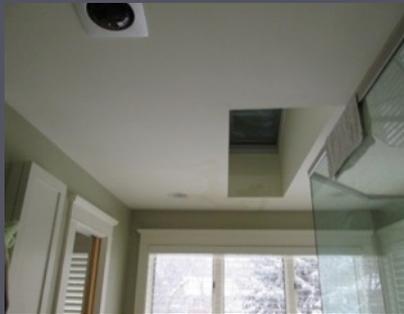
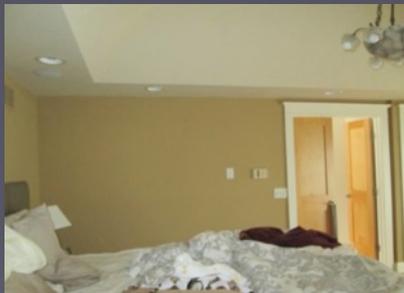
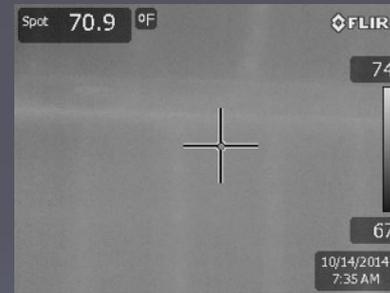
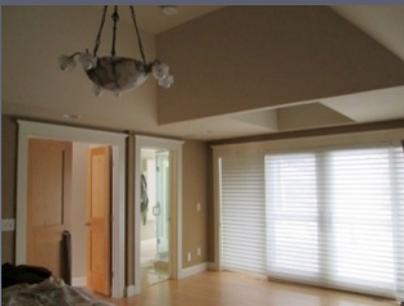
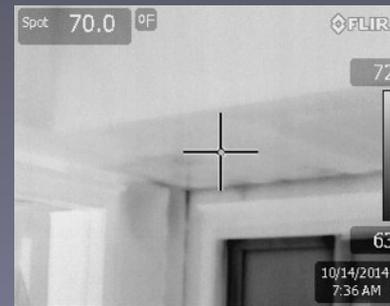
Post Test

MEASUREMENT	PRE TEST	POST TEST	REDUCTION	% REDUCTION
Air Leakage (CFM50)	2924	2336	588	20%
Air Changes (ACH50)	3.62	2.89	0.73	20%

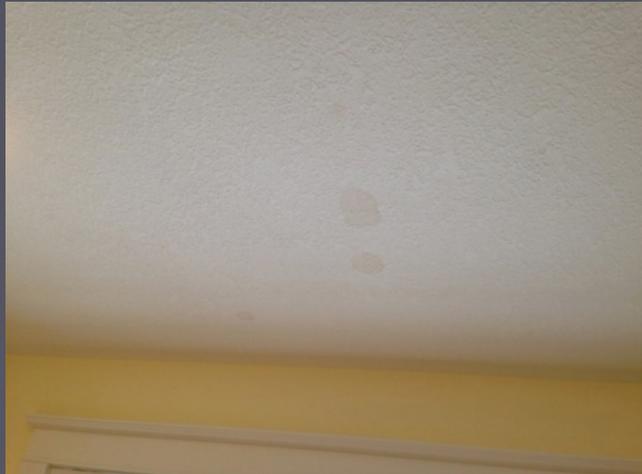
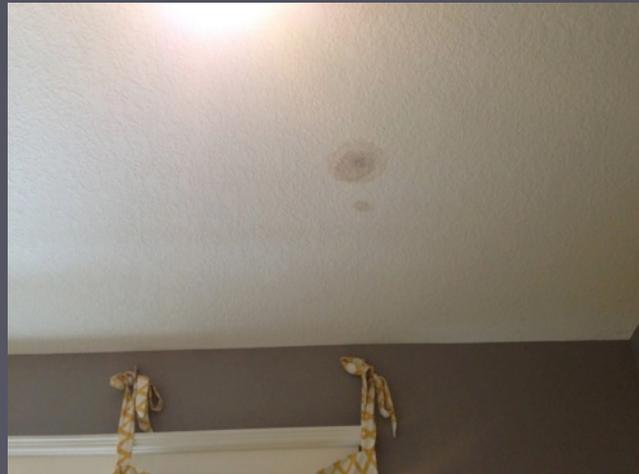
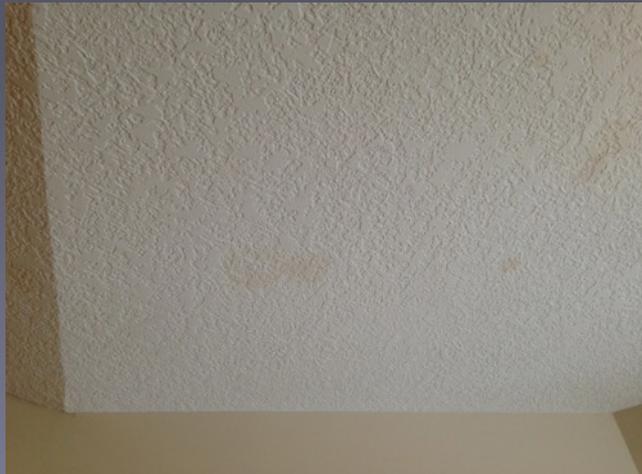
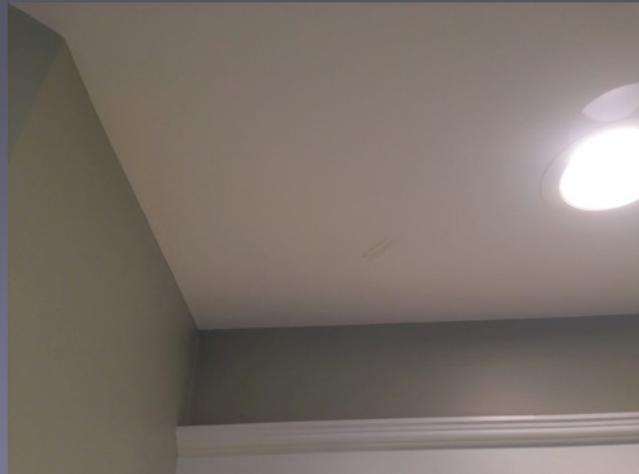
Effect of not air sealing front slant

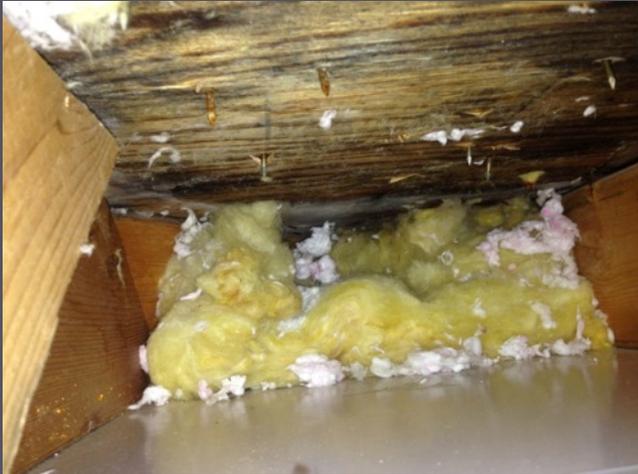
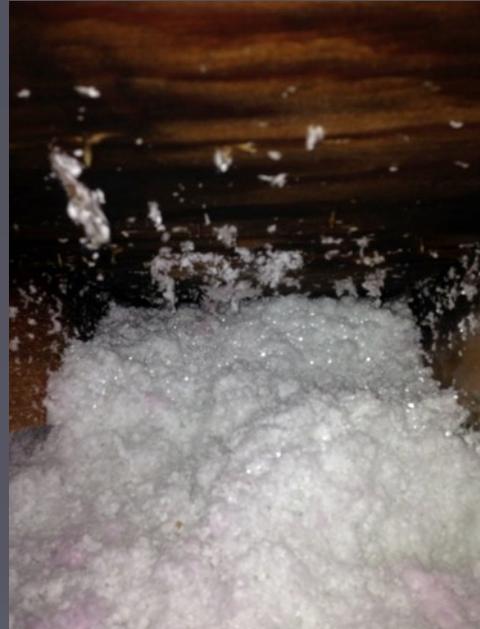
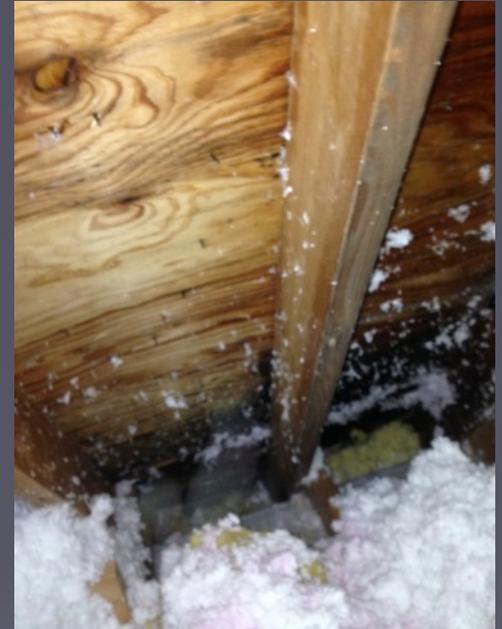
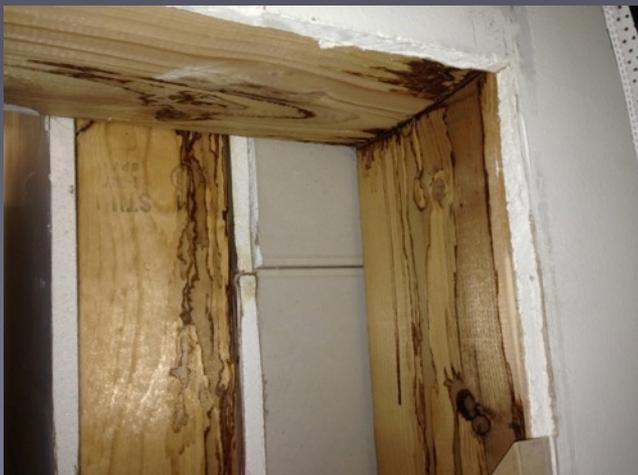
What effects did not air sealing the front slants have?
